Report No: 4788945807
Report Date: 2019-07-31

List of tests	Page
Corrosion tests in artificial atmospheres - Salt spray tests - ISO 9227	6

Corrosion tests in artificial atmospheres – Salt spray tests - ISO 9227

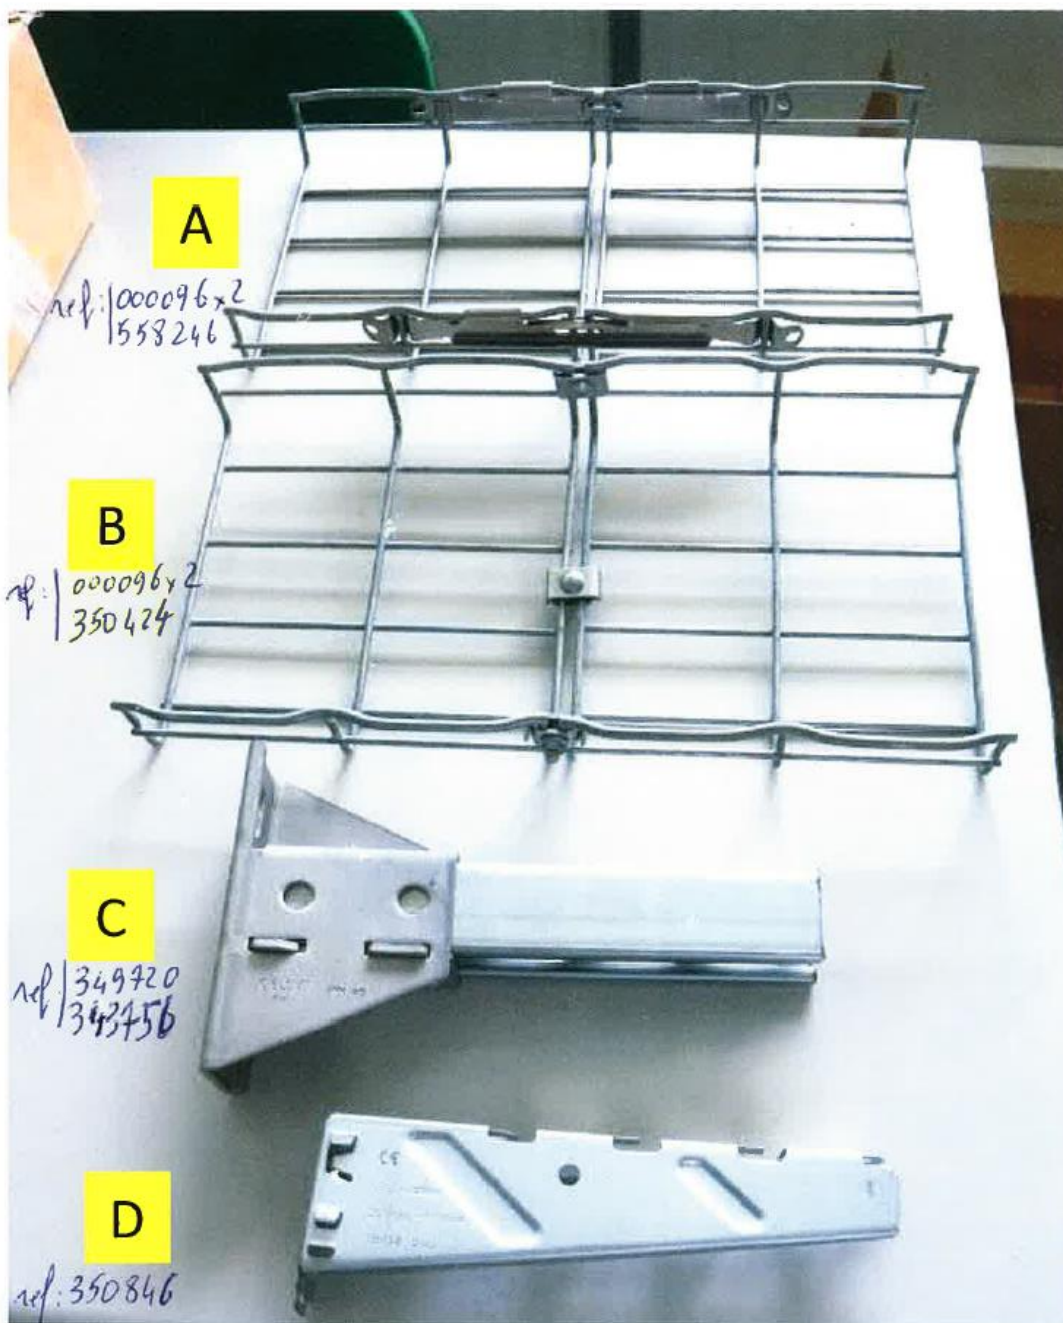
Picture 1: Sample description by client

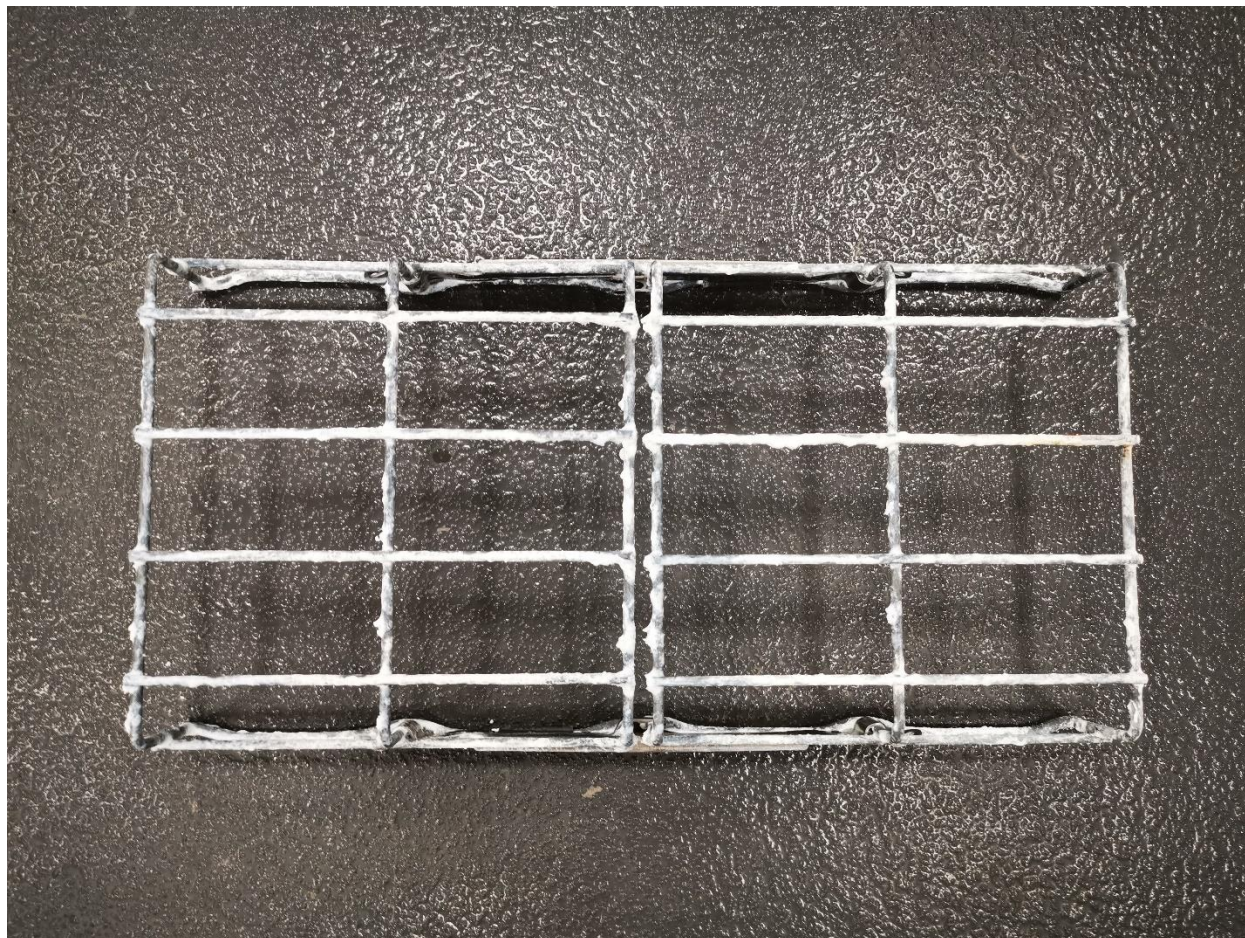
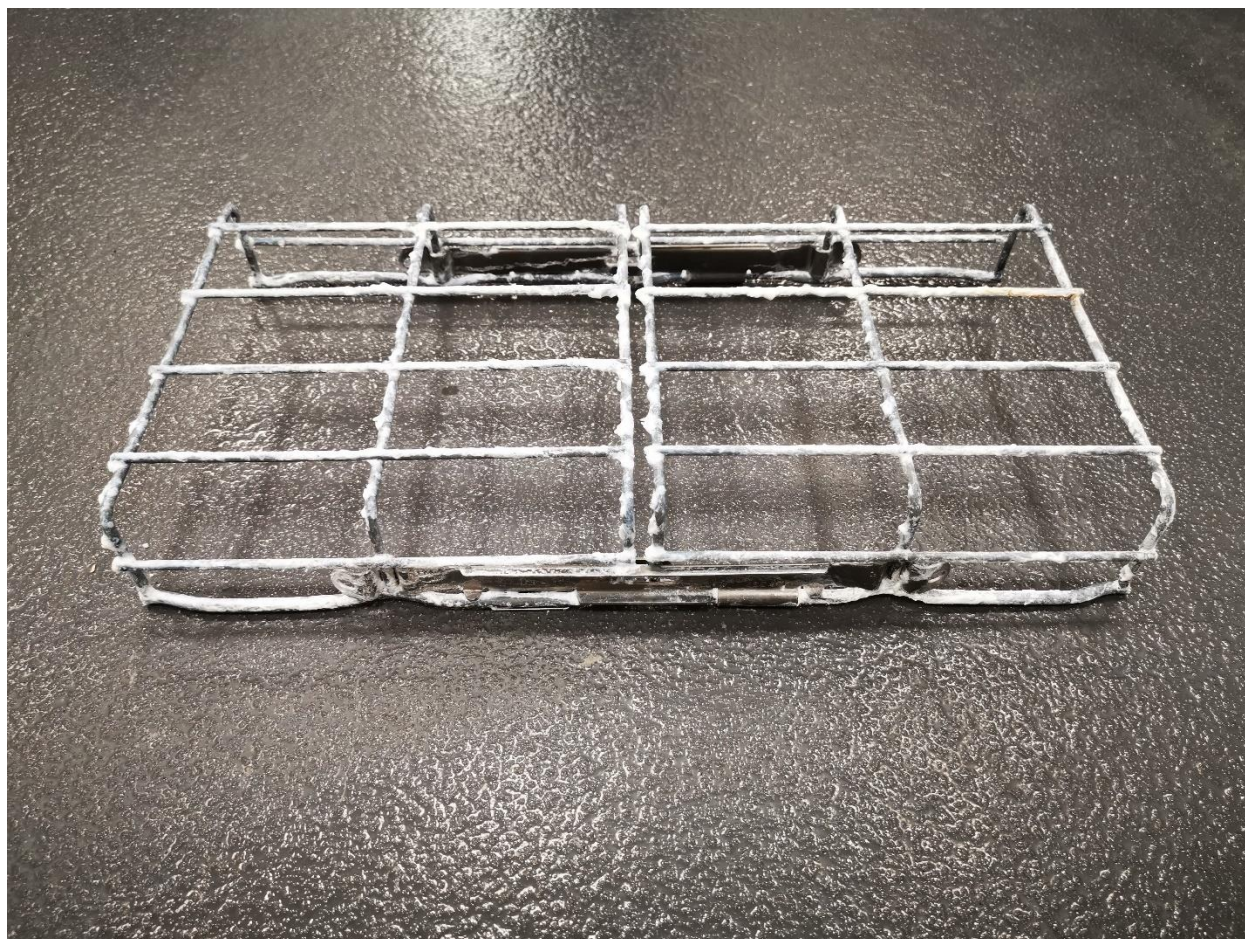
Picture 2: Picture of sample 1 after testing

Picture 3: Picture of sample 1 after testing

Lightly visible rust on a part of sample 1 (picture 17). In general no more rust than 1% of the complete surface of sample 1. For samples 2 and 3 there were minimal rust (less than 0.5% of the surface). Sample 4 had no visible rust on the surface.

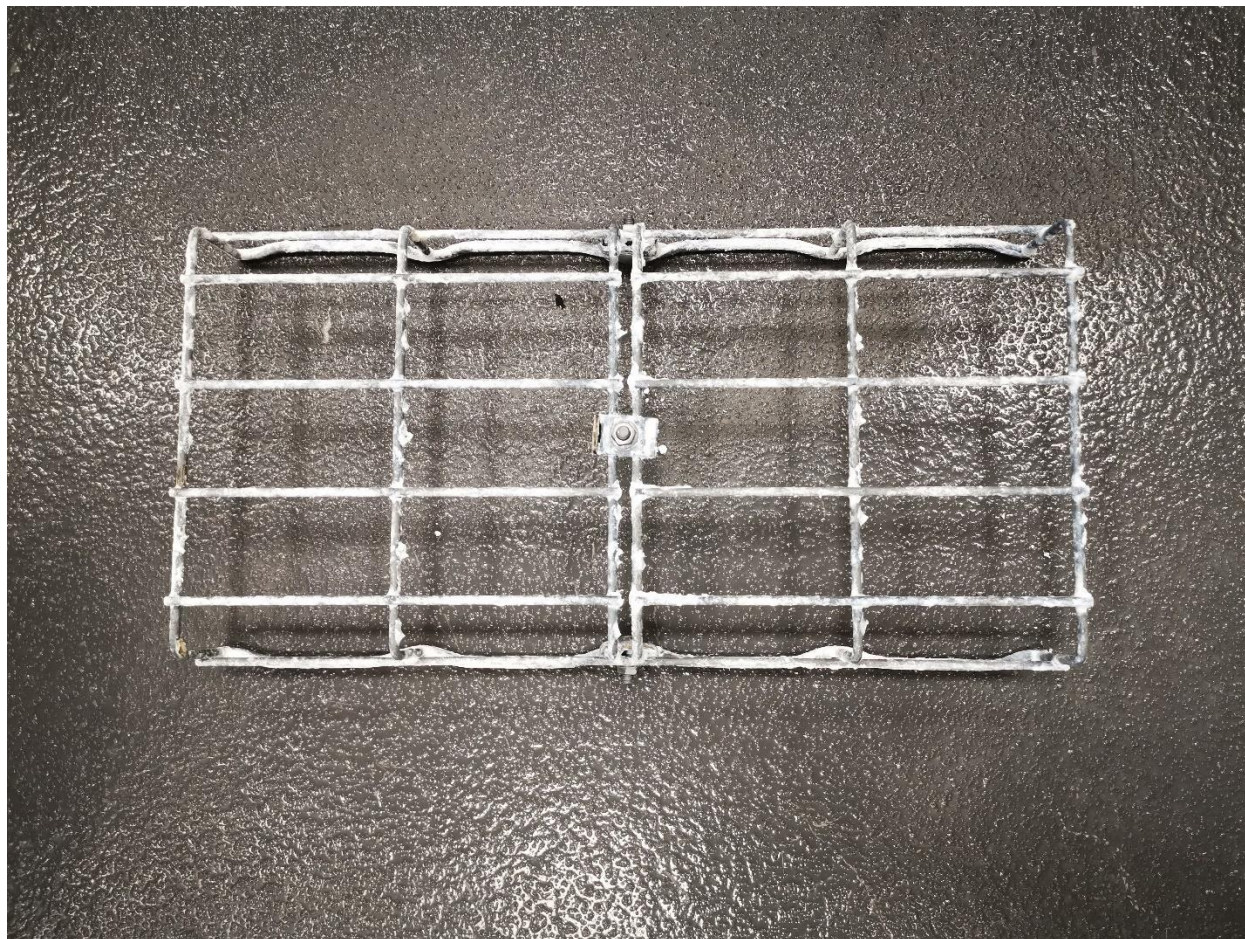
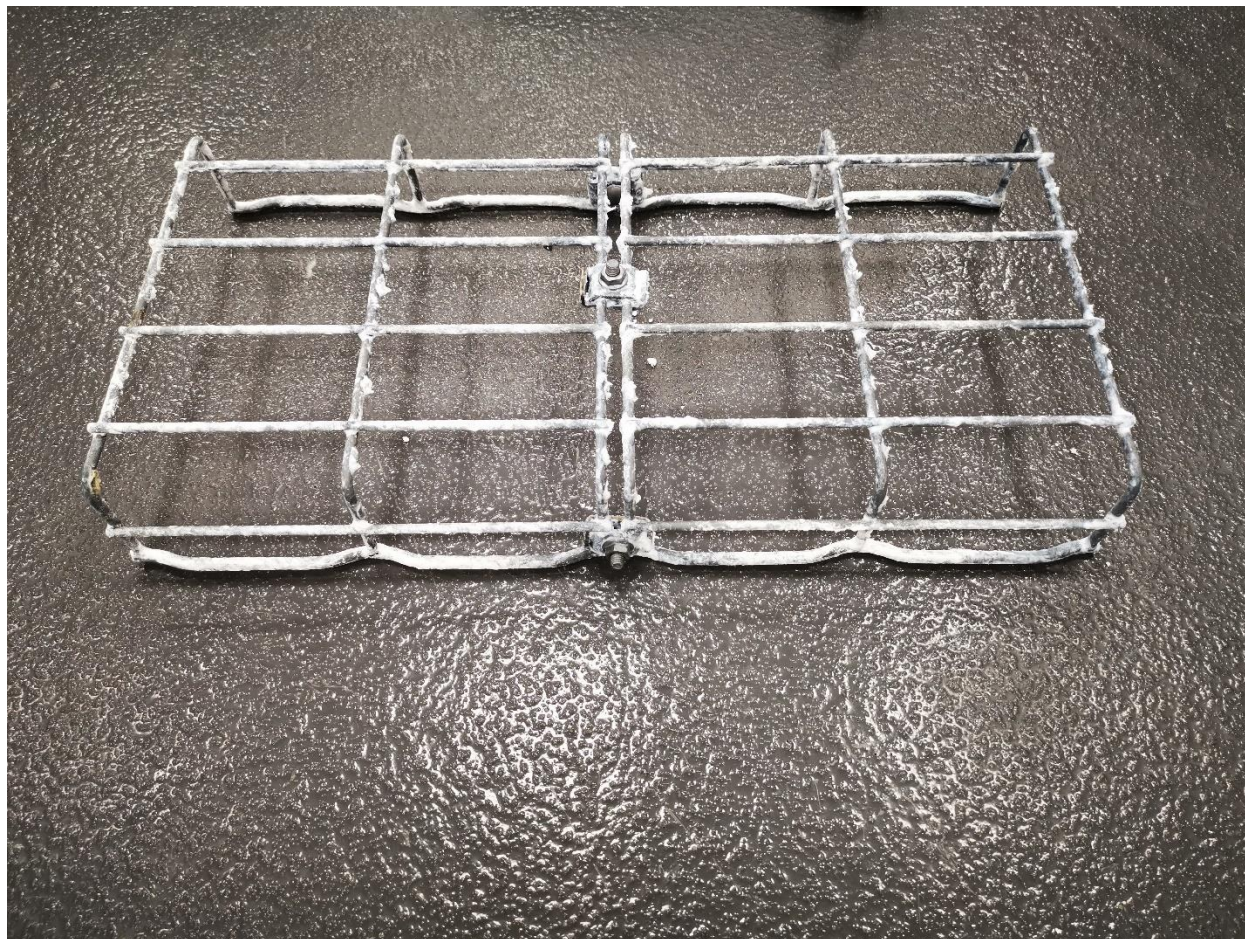
Picture 4: Picture of sample 2 after testing

Picture 5: Picture of sample 2 after testing

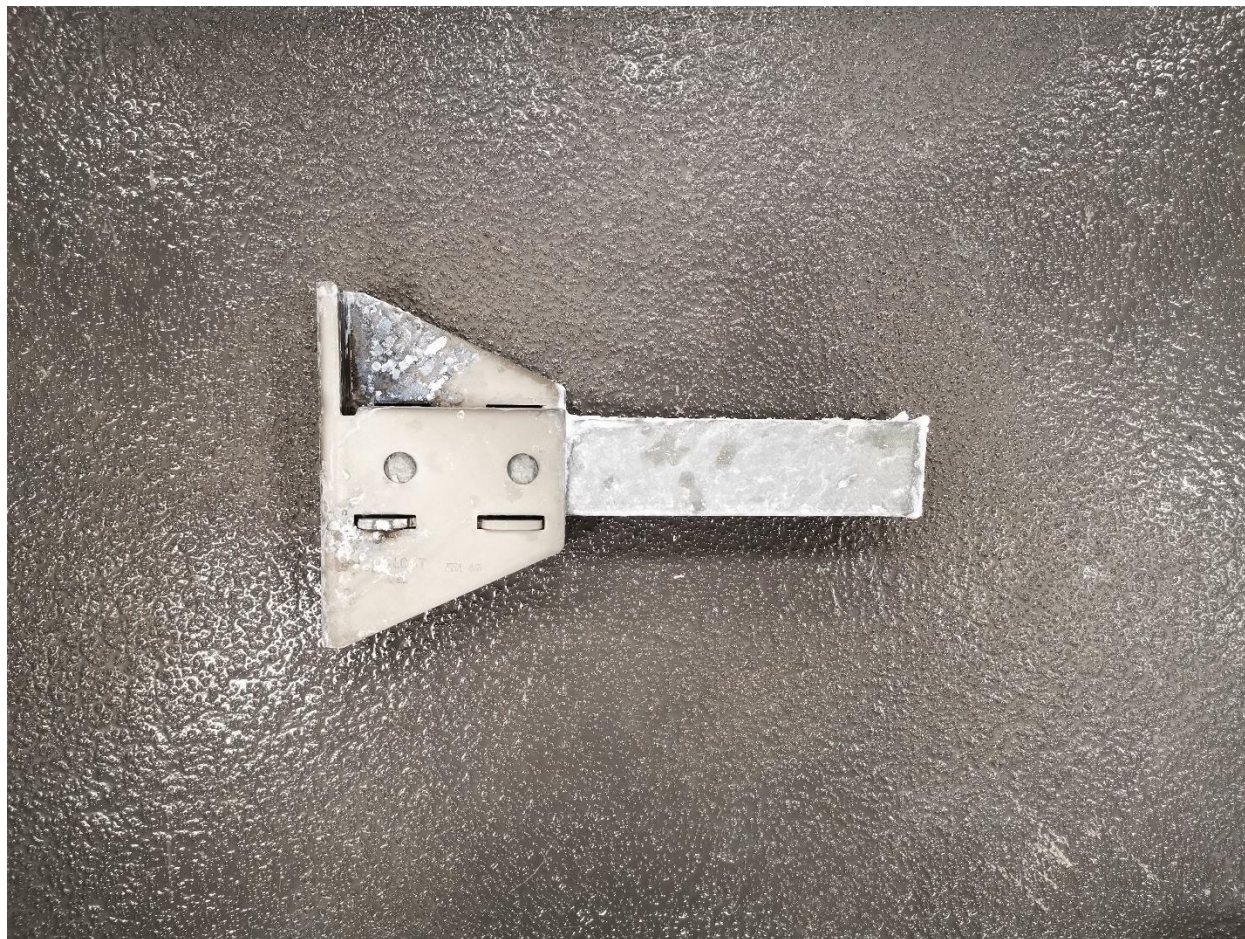
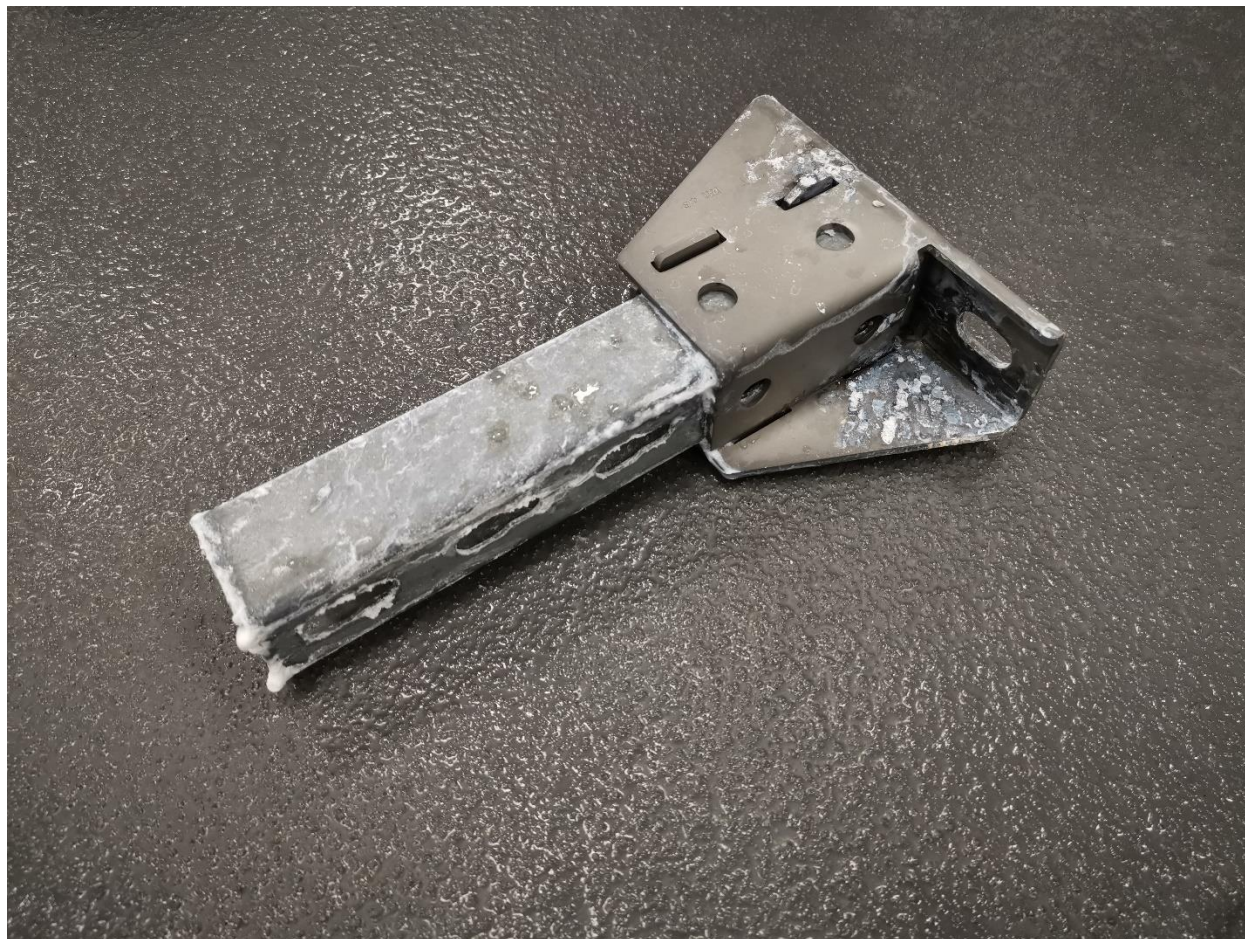
Picture 6: Picture of sample 3 after testing

Picture 7: Picture of sample 3 after testing

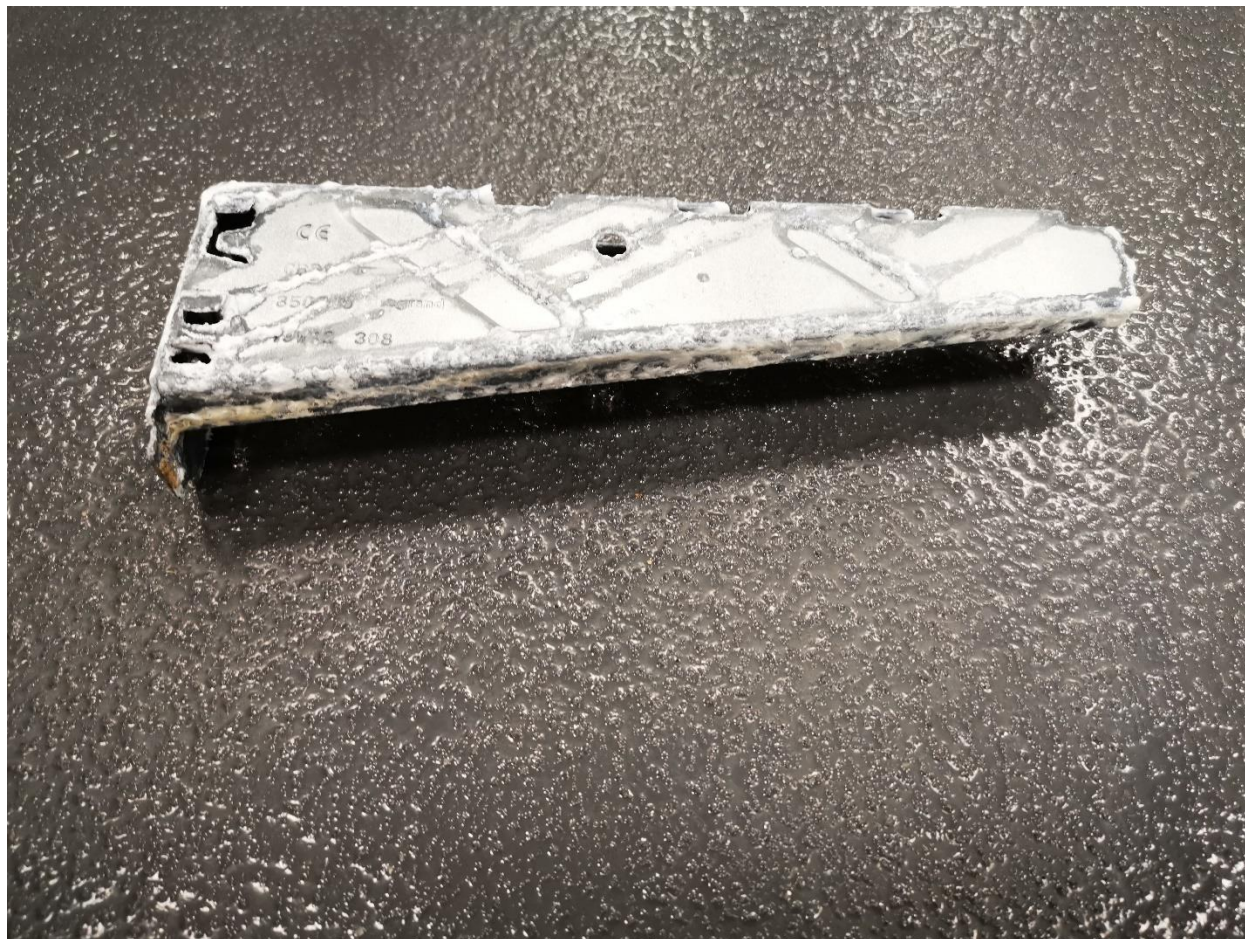
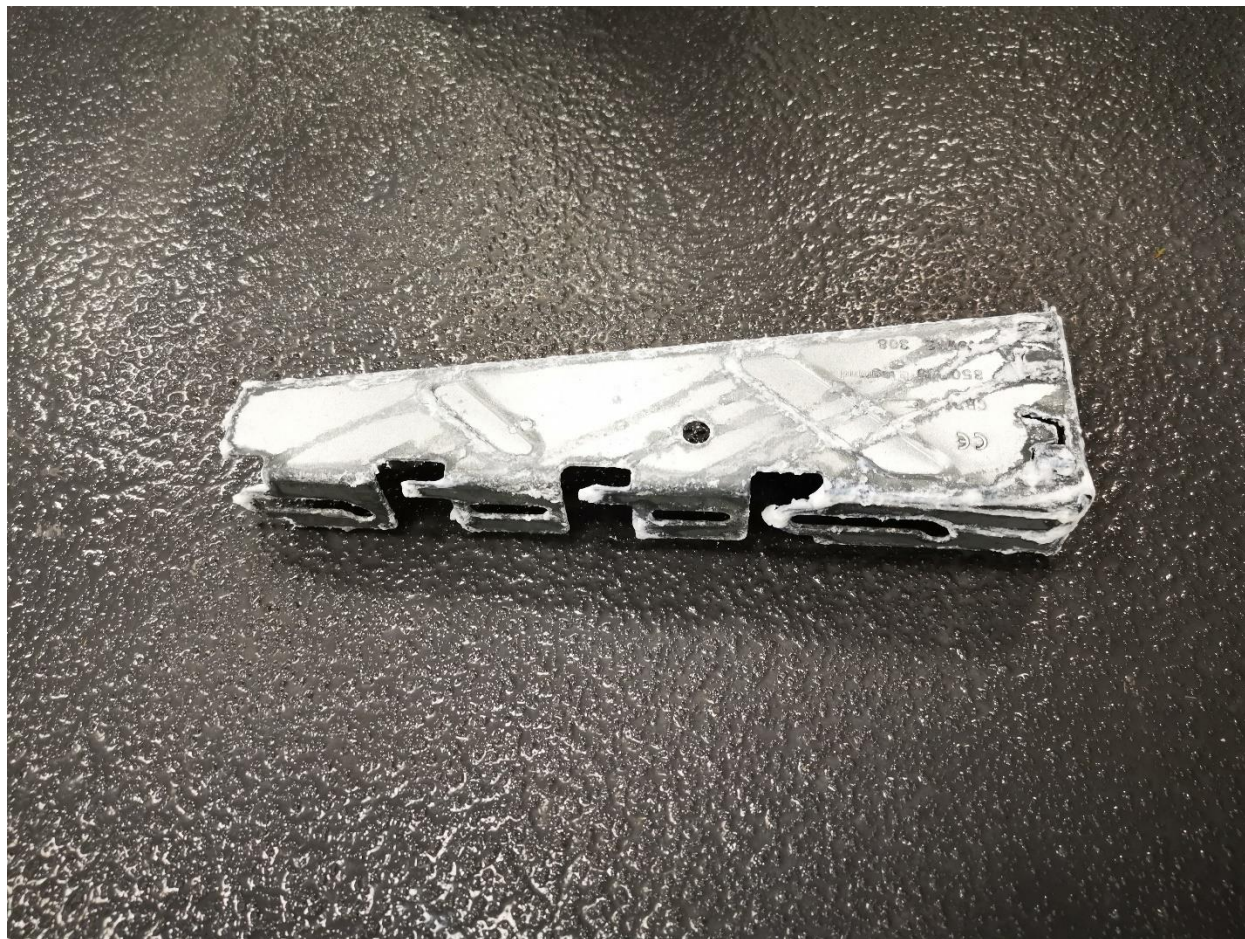
Picture 8: Picture of sample 4 after testing

Picture 9: Picture of sample 4 after testing

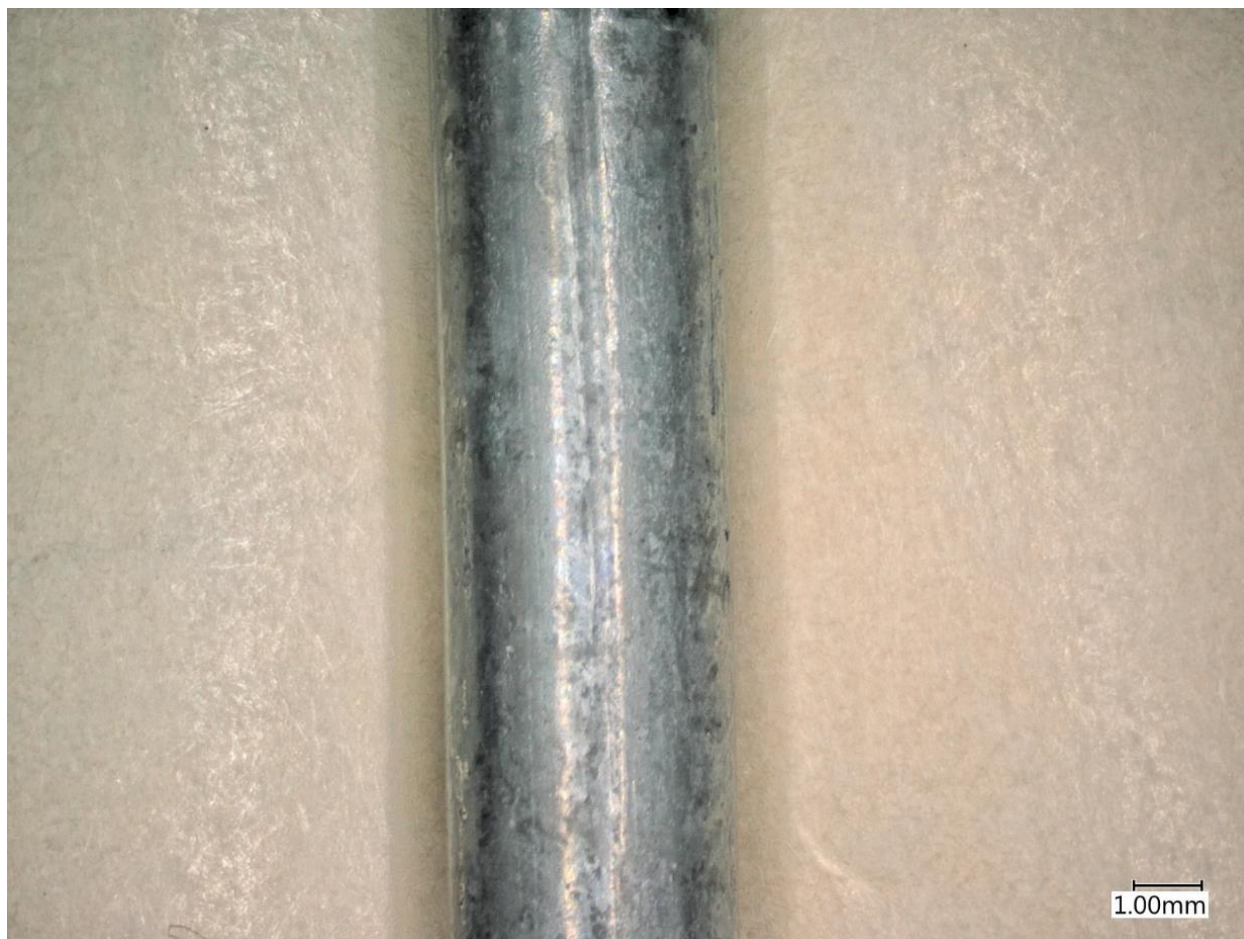
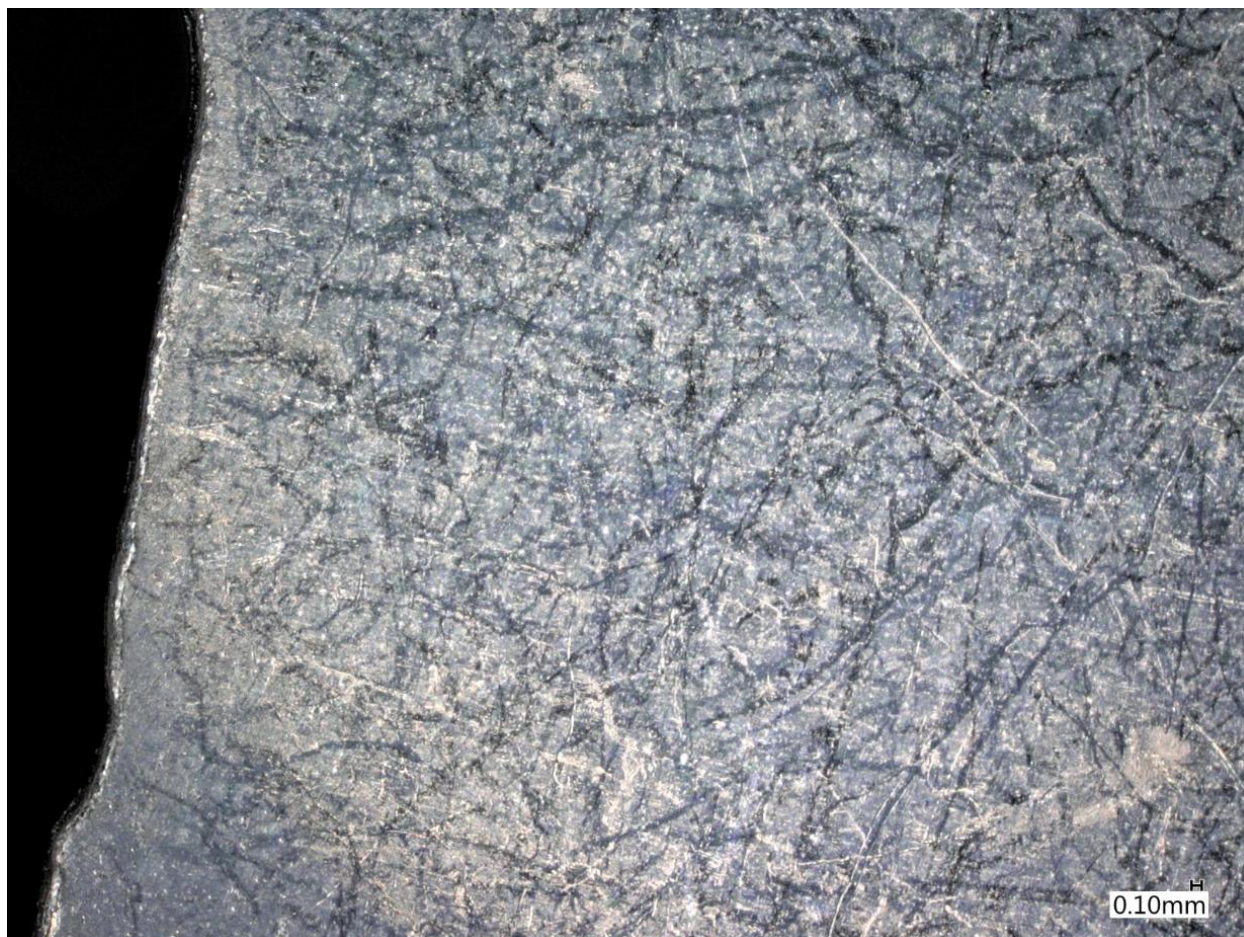
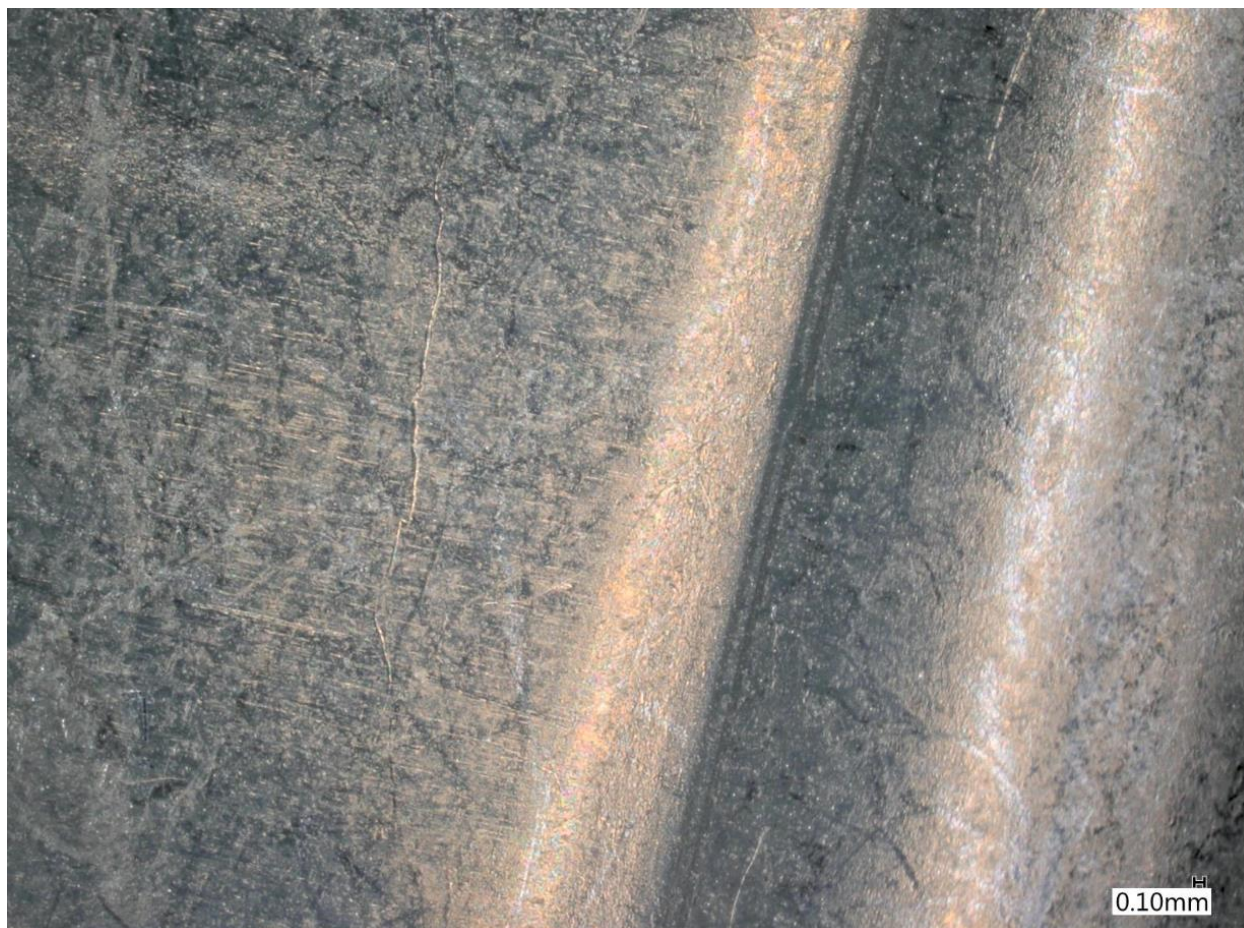
Picture 10: Microscope picture of sample 1 as received

Picture 12: Microscope picture of sample 1 as received

Picture 14: Microscope picture of sample 1 as received

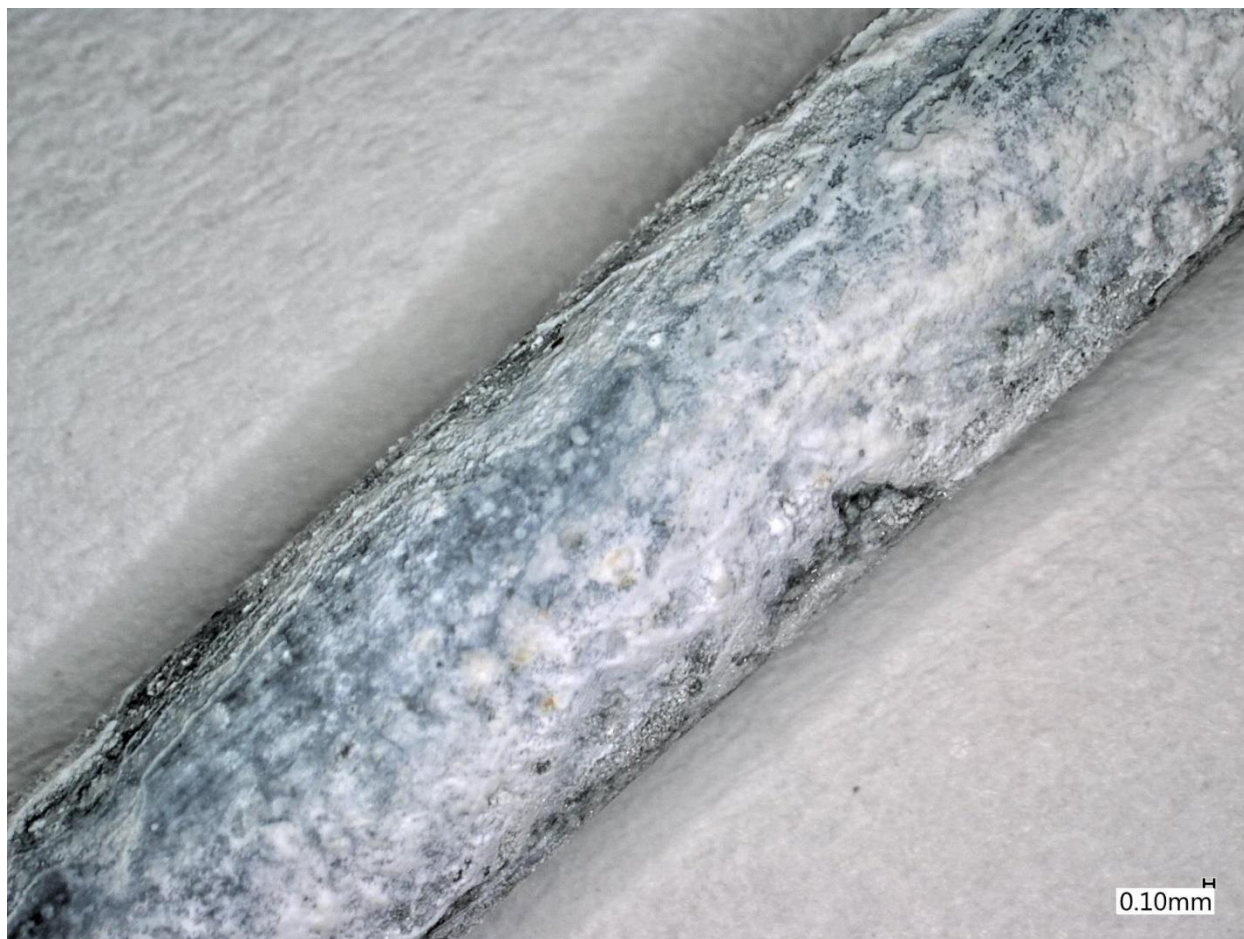
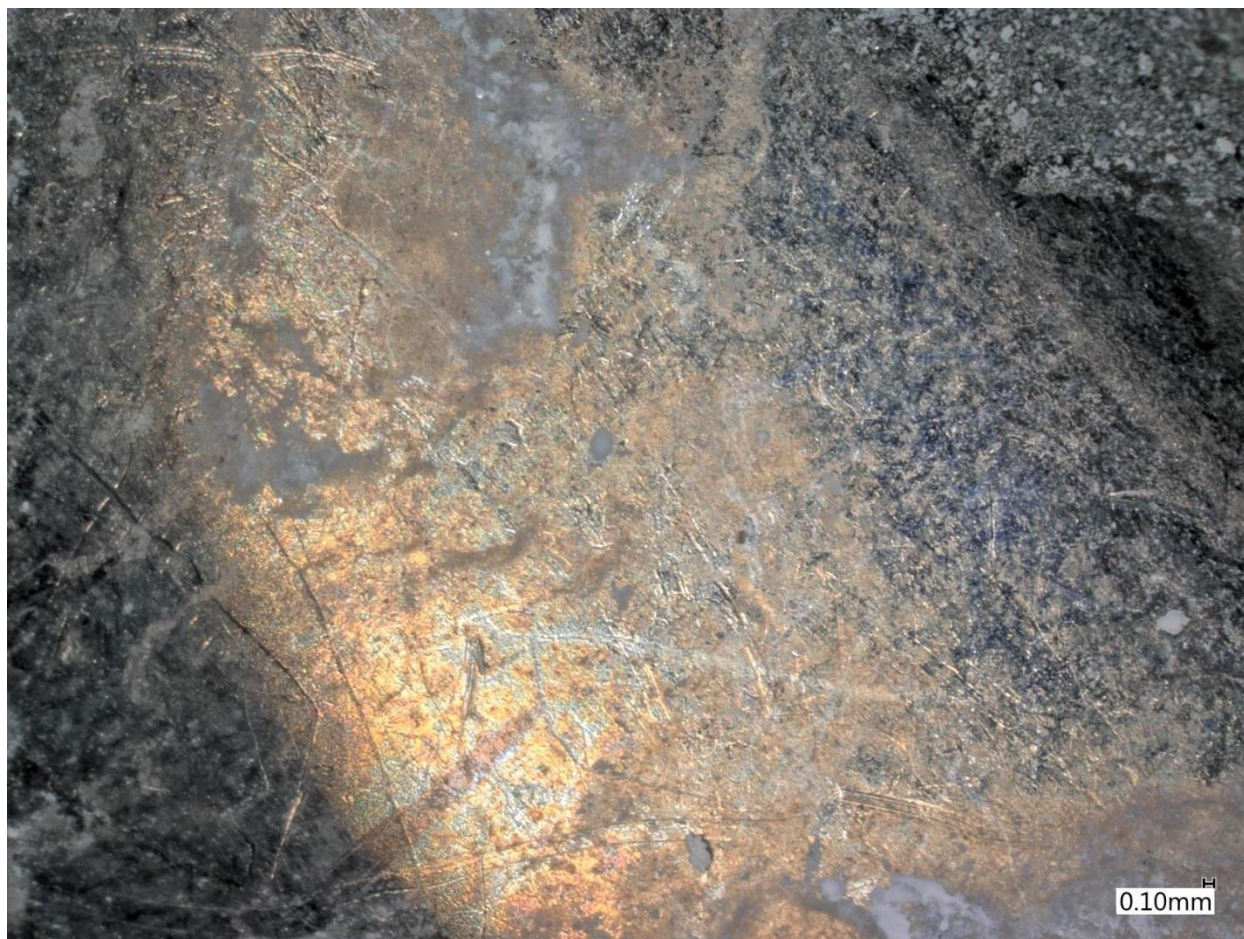
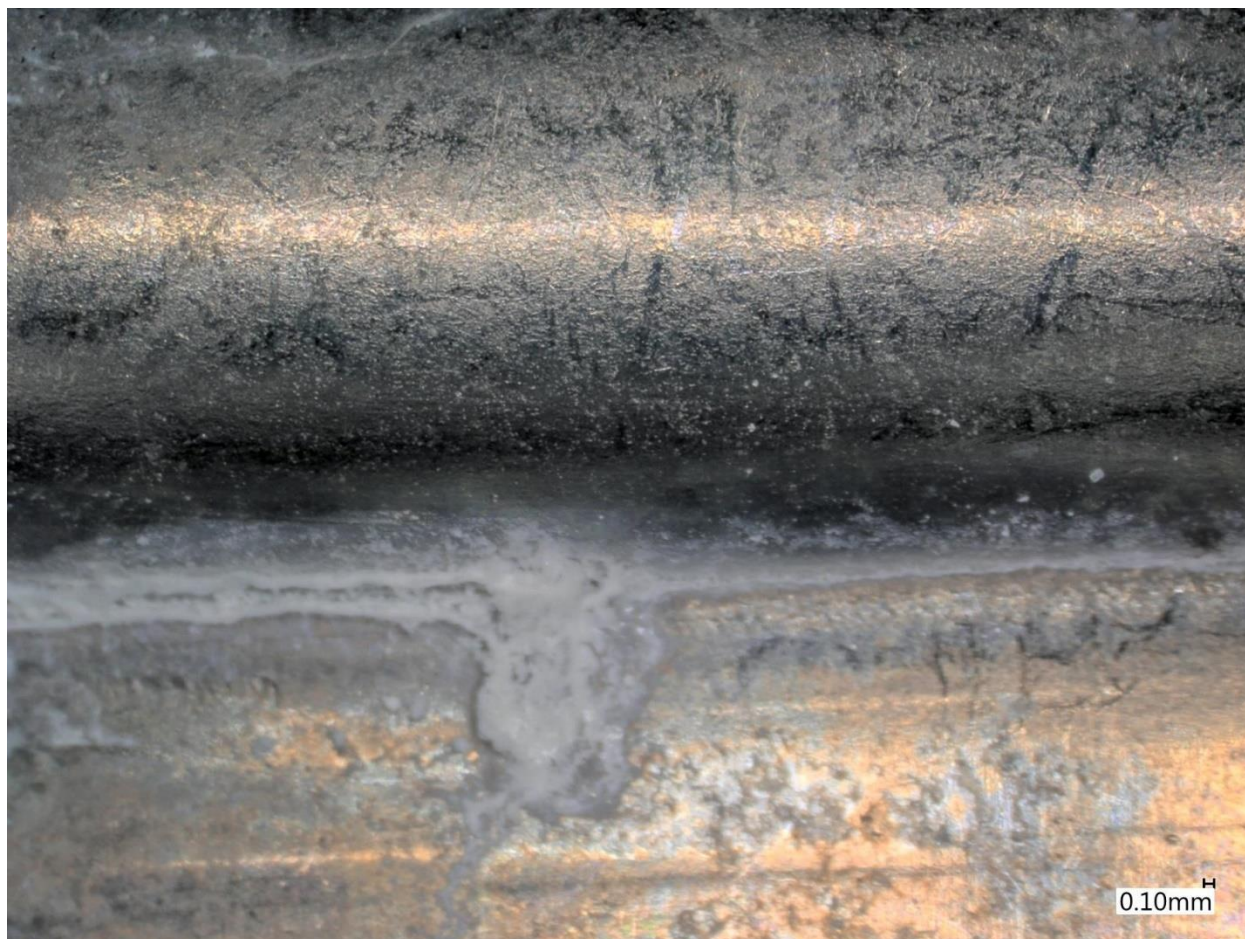
Picture 11: Microscope picture of sample 1 after testing

Picture 13: Microscope picture of sample 1 after testing

Picture 15: Microscope picture of sample 1 after testing

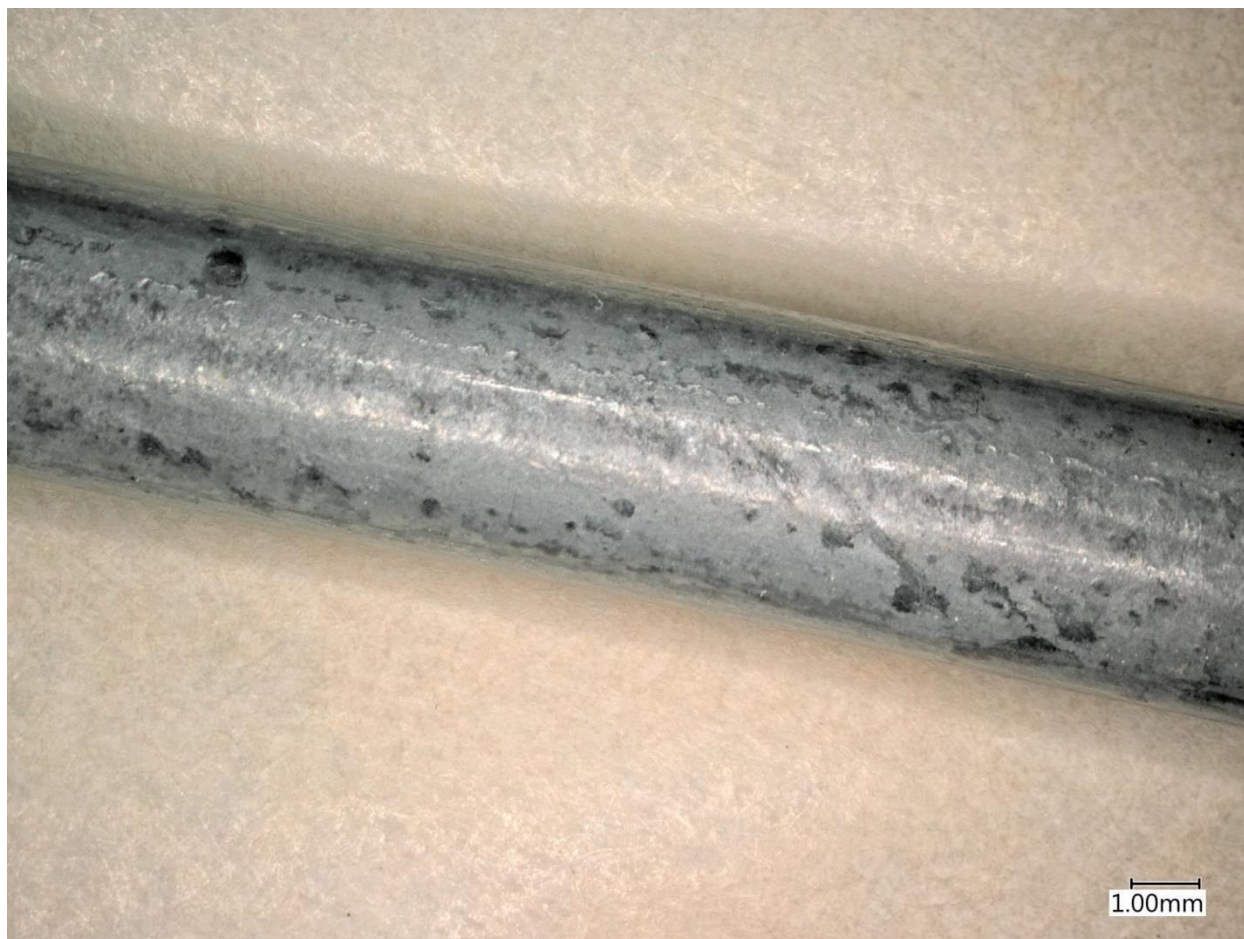
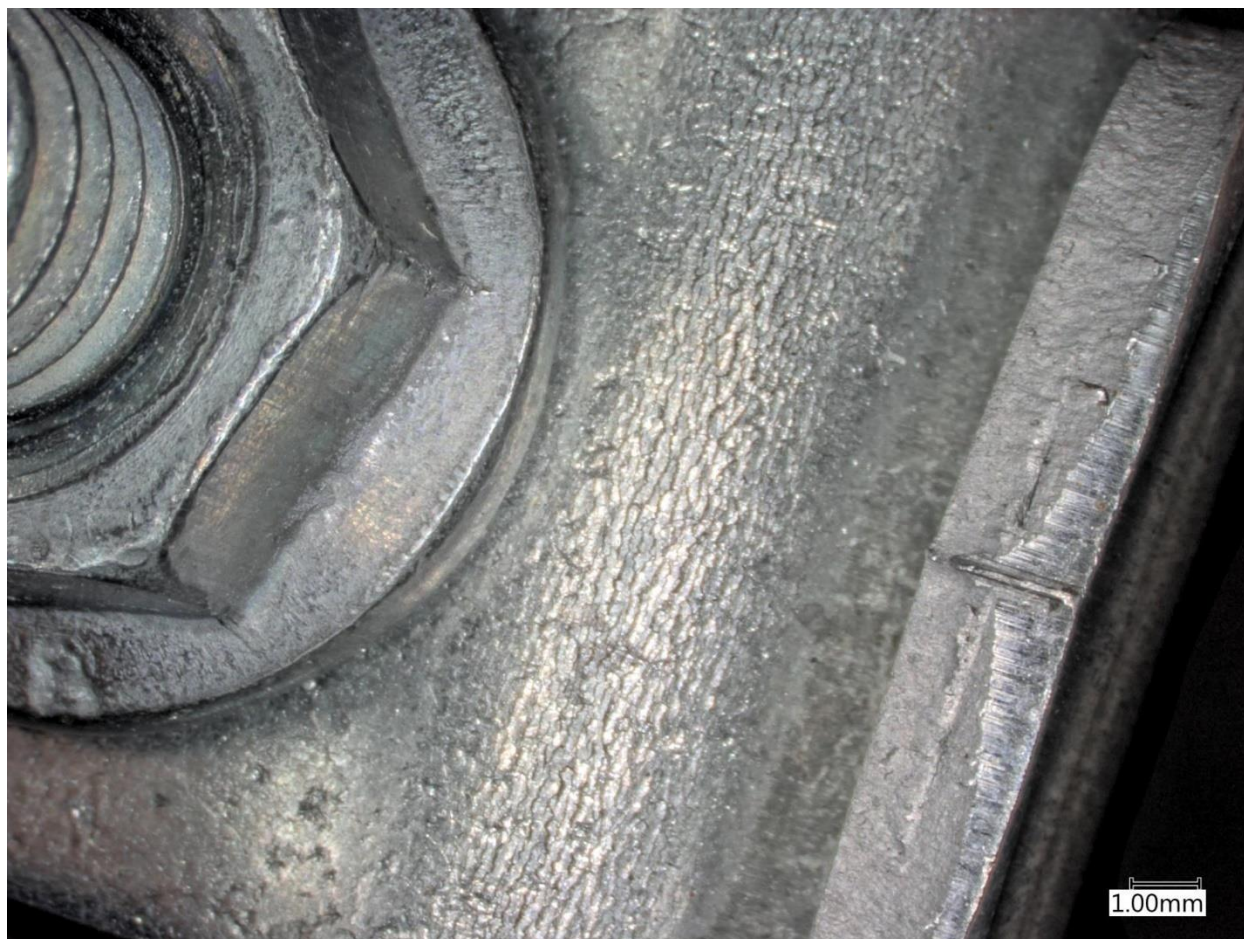
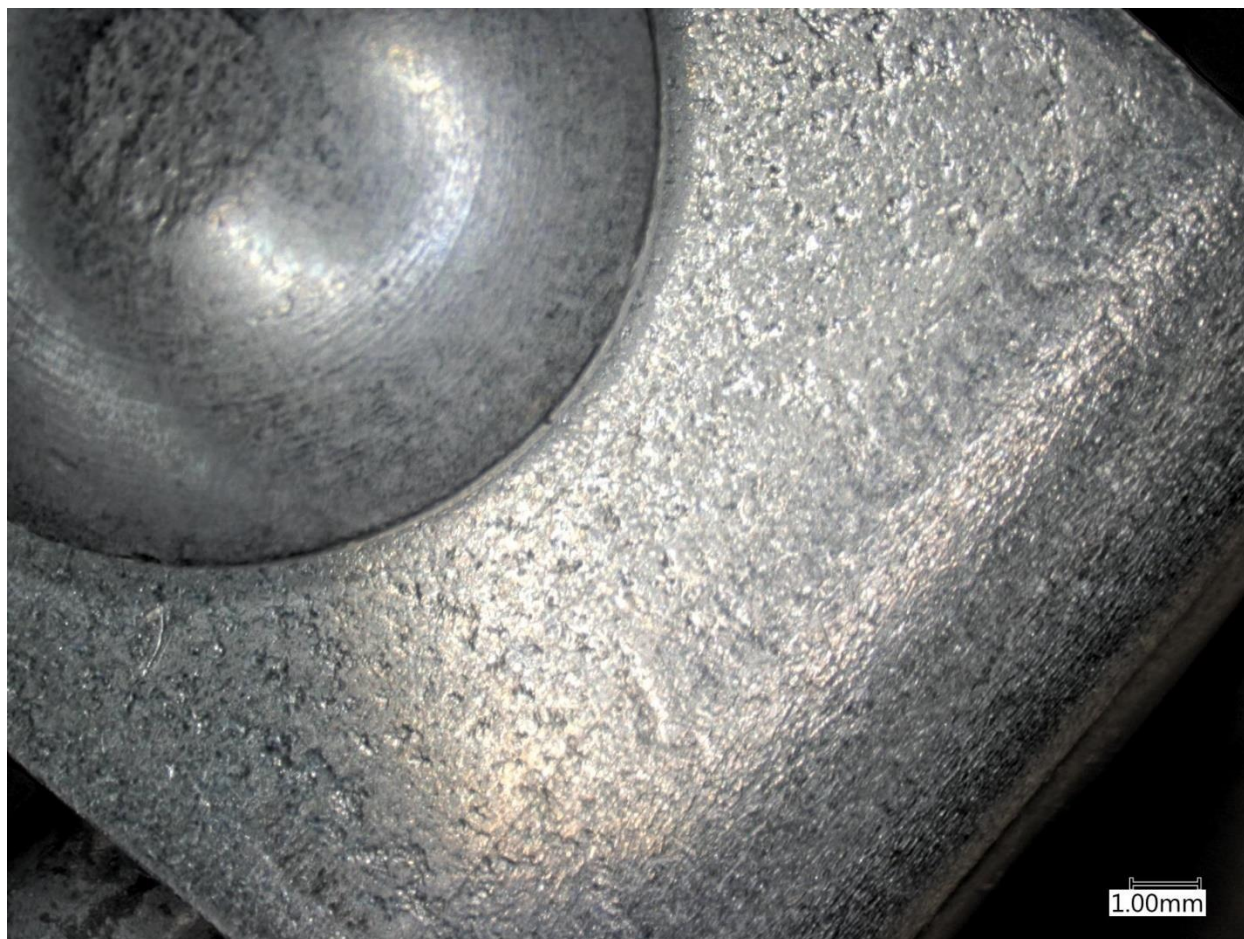
Picture 16: Microscope picture of sample 2 as received

Picture 18: Microscope picture of sample 2 as received

Picture 20: Microscope picture of sample 2 as received

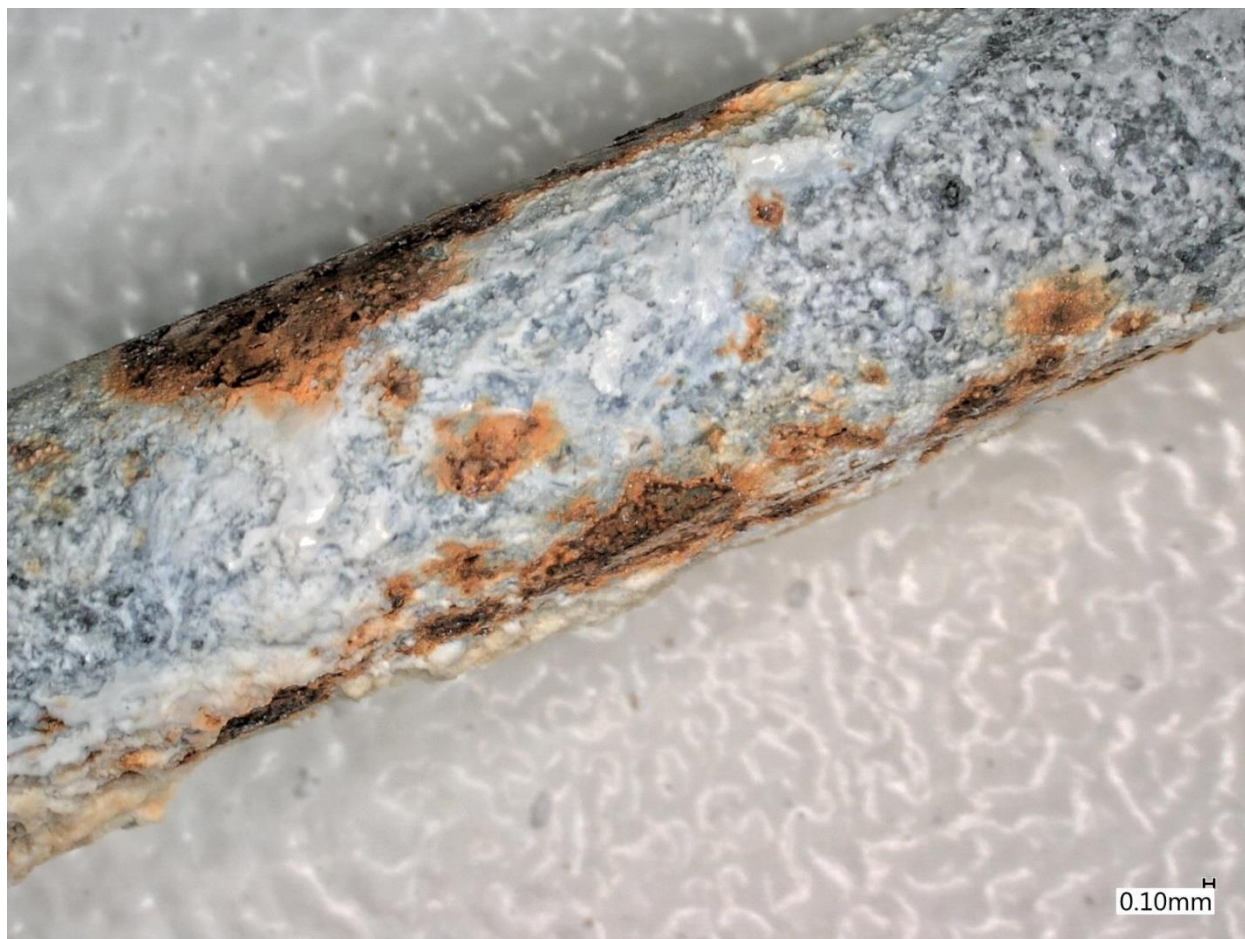
Picture 17: Microscope picture of sample 2 after testing
