Report No: 4788945807
Report Date: 2019-07-31

List of tests	Page
Corrosion tests in artificial atmospheres - Salt spray tests - ISO 9227	6

Corrosion tests in artificial atmospheres – Salt spray tests - ISO 9227

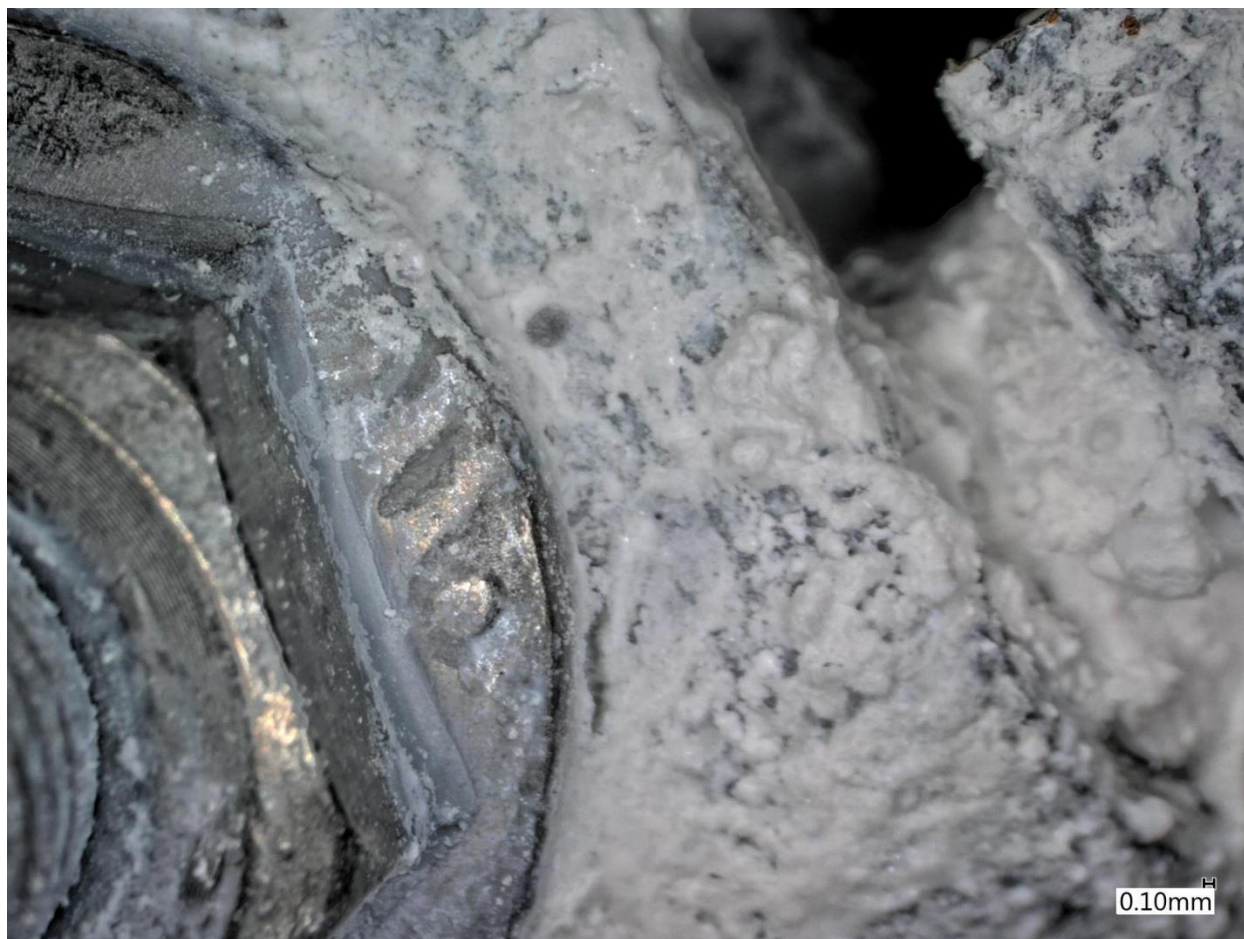
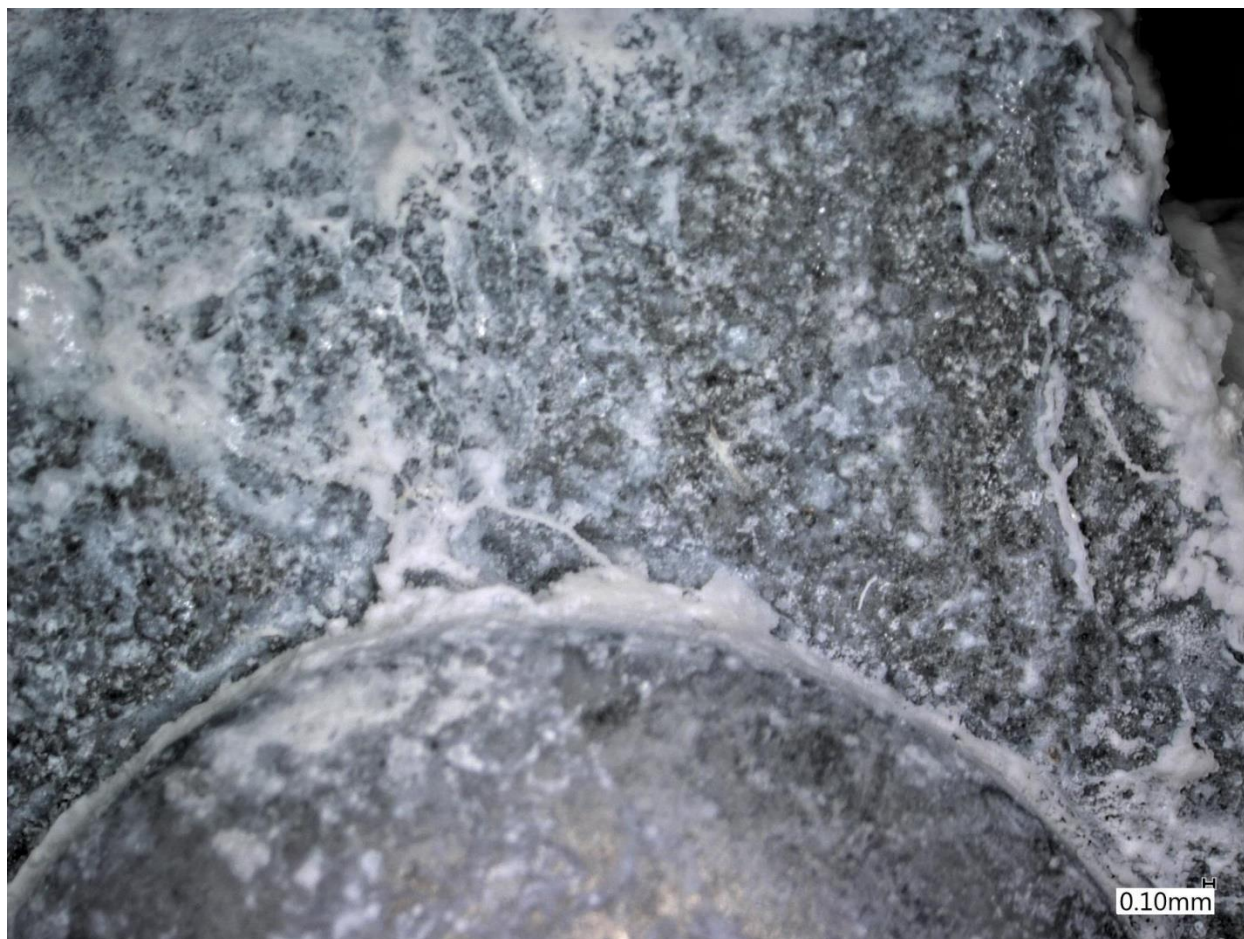
Picture 19: : Microscope picture of sample 2 after testing

Picture 21: Microscope picture of sample 2 after testing

Lightly visible rust on a part of sample 1 (picture 17). In general no more rust than 1% of the complete surface of sample 1. For samples 2 and 3 there were minimal rust (less than 0.5% of the surface). Sample 4 had no visible rust on the surface.

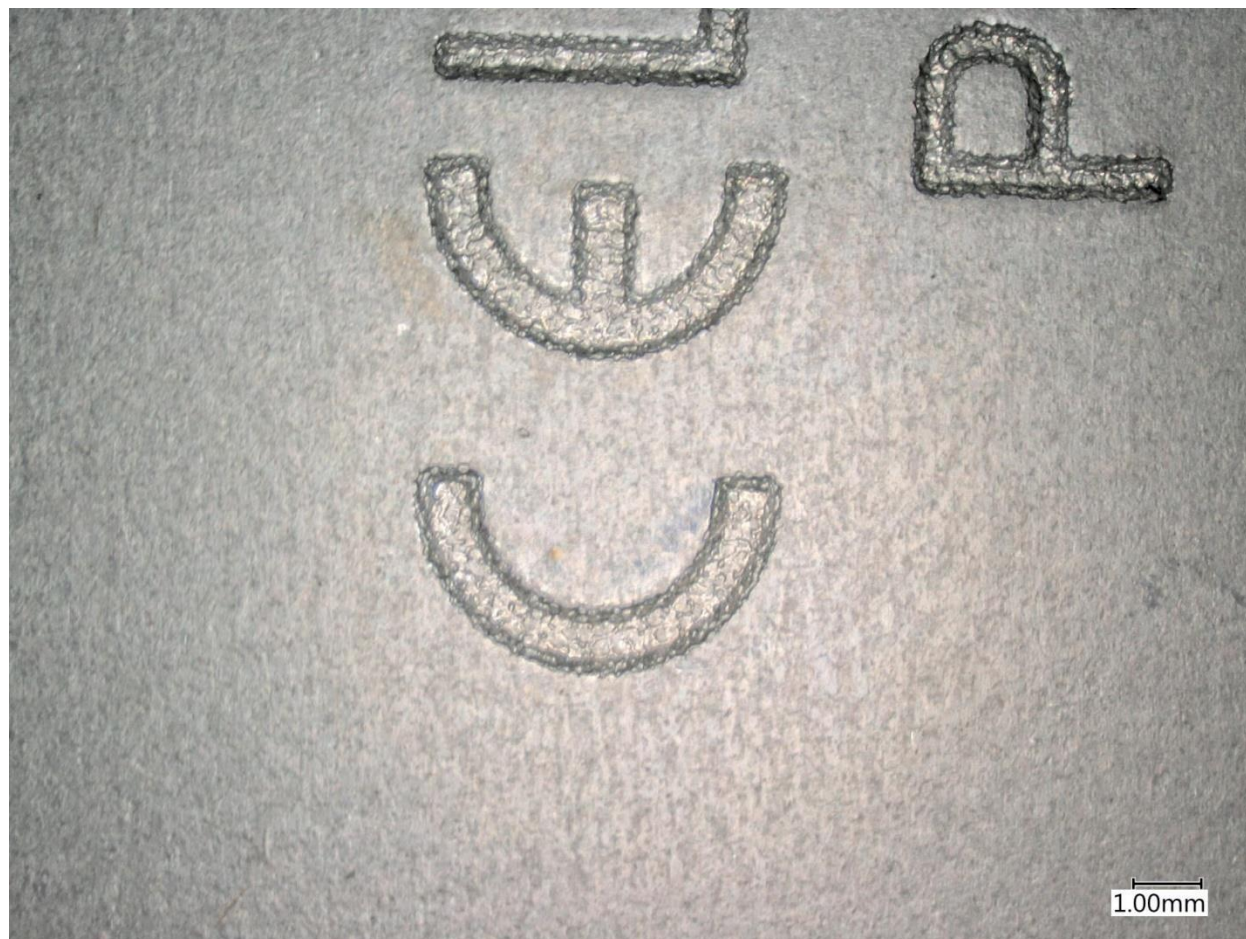
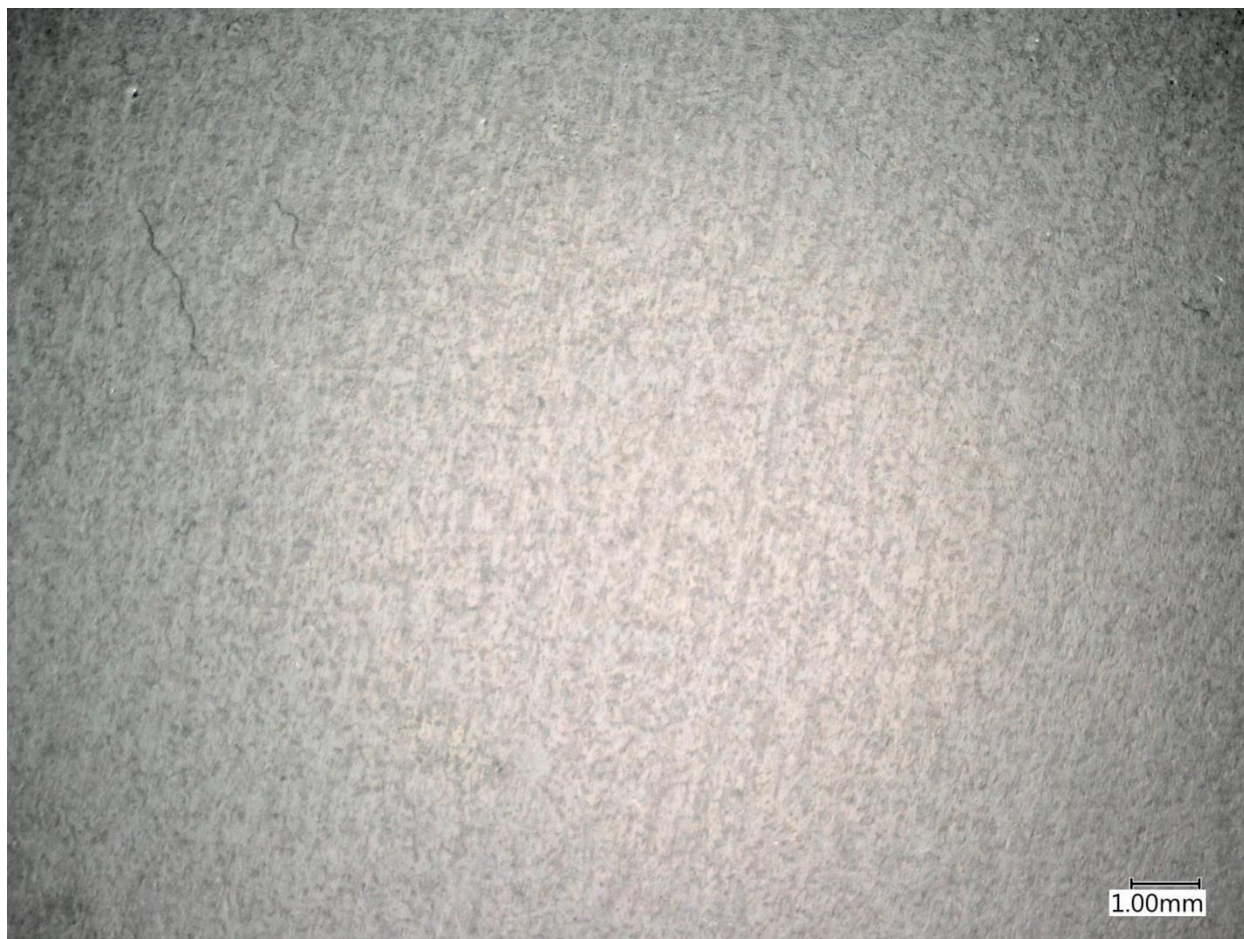
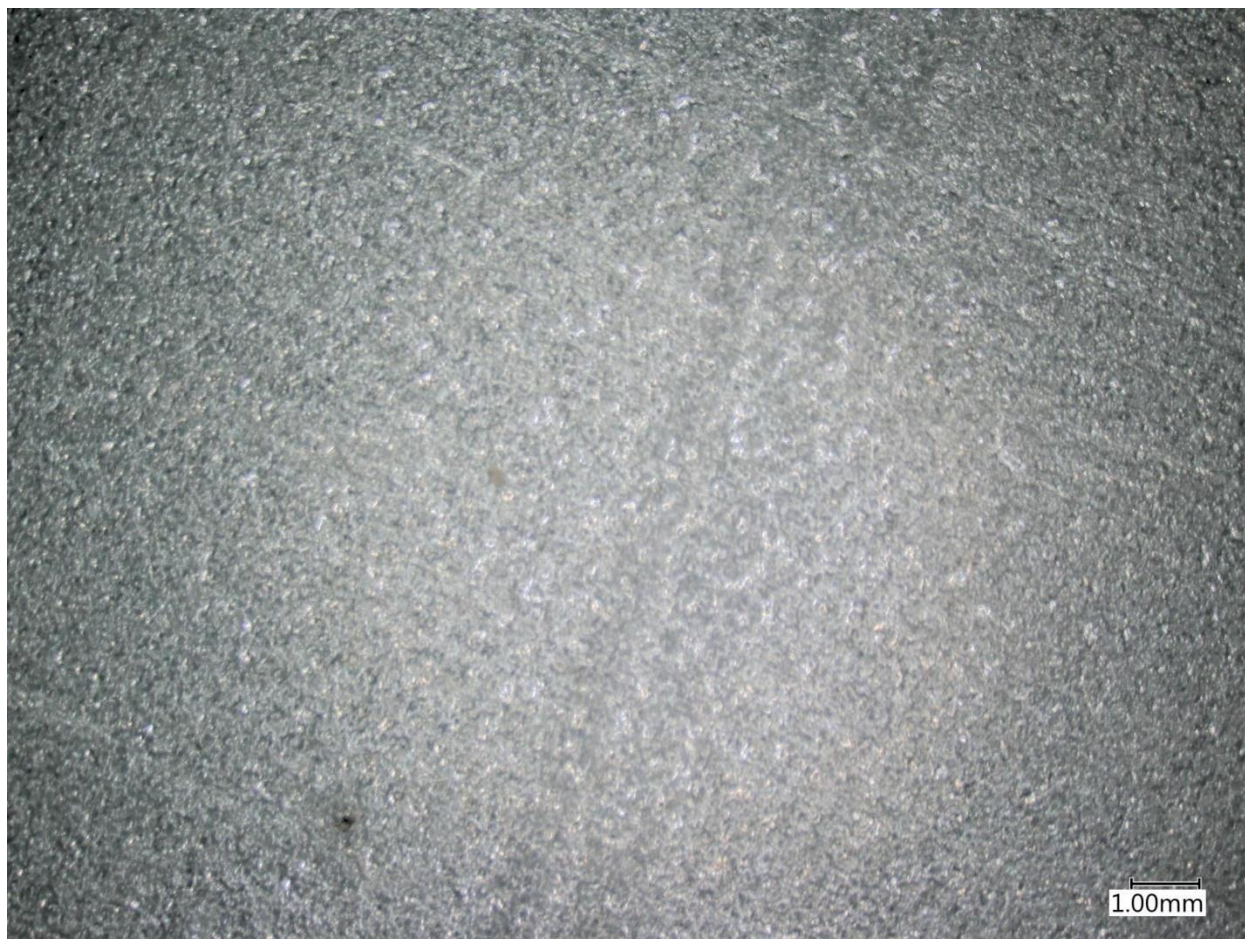
Picture 22: Microscope picture of sample 3 as received

Picture 24: Microscope picture of sample 3 as received

Picture 26: Microscope picture of sample 3 as received

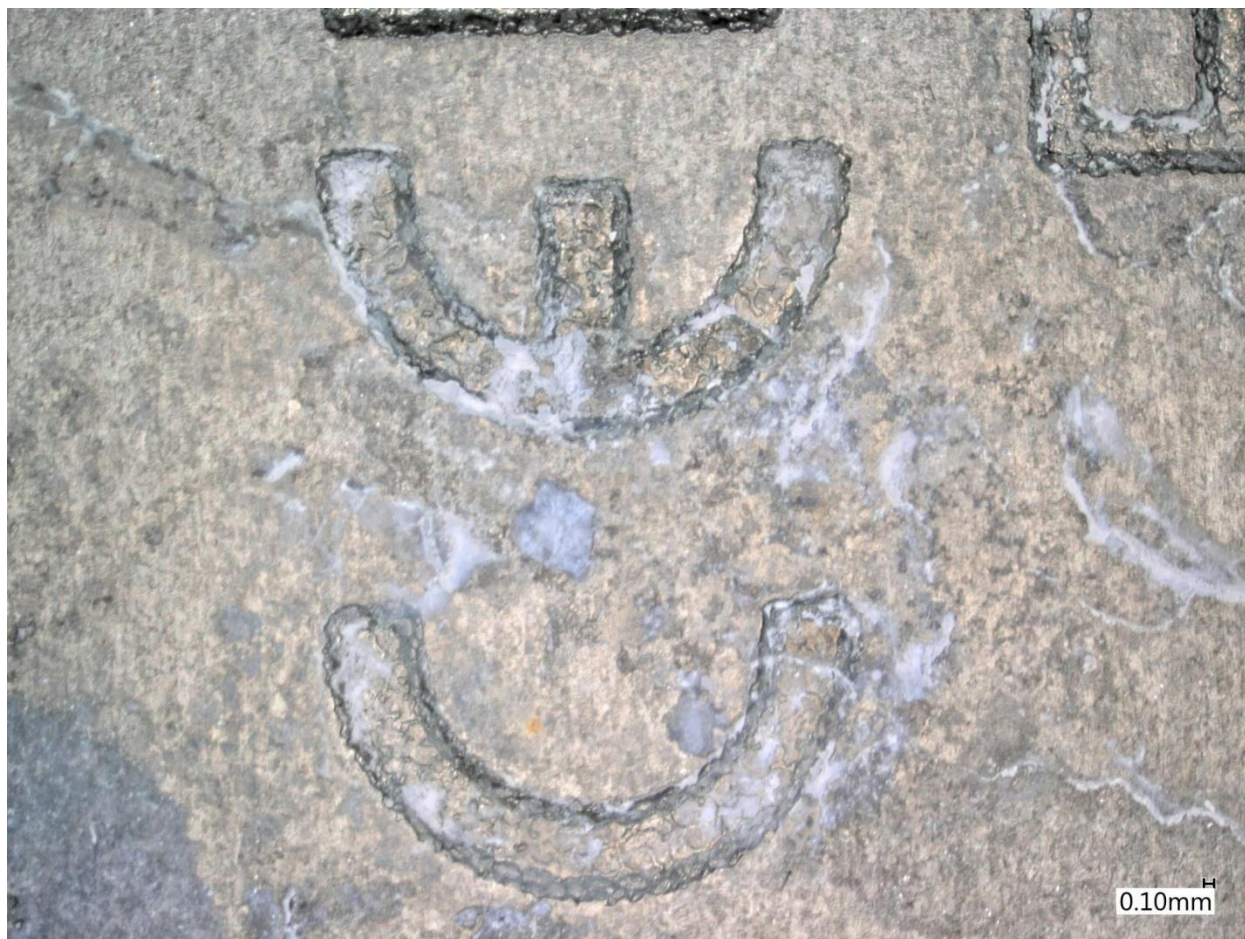
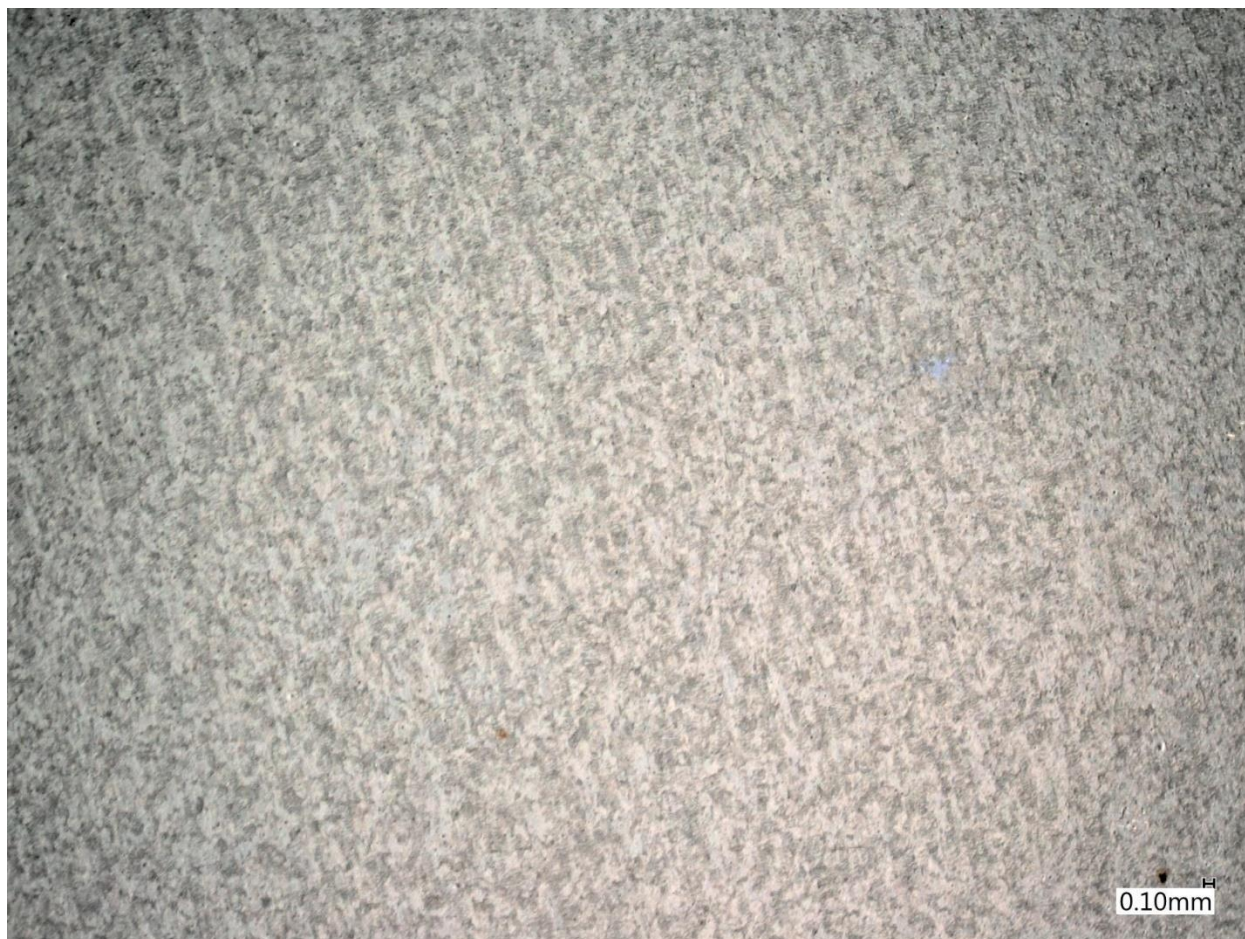
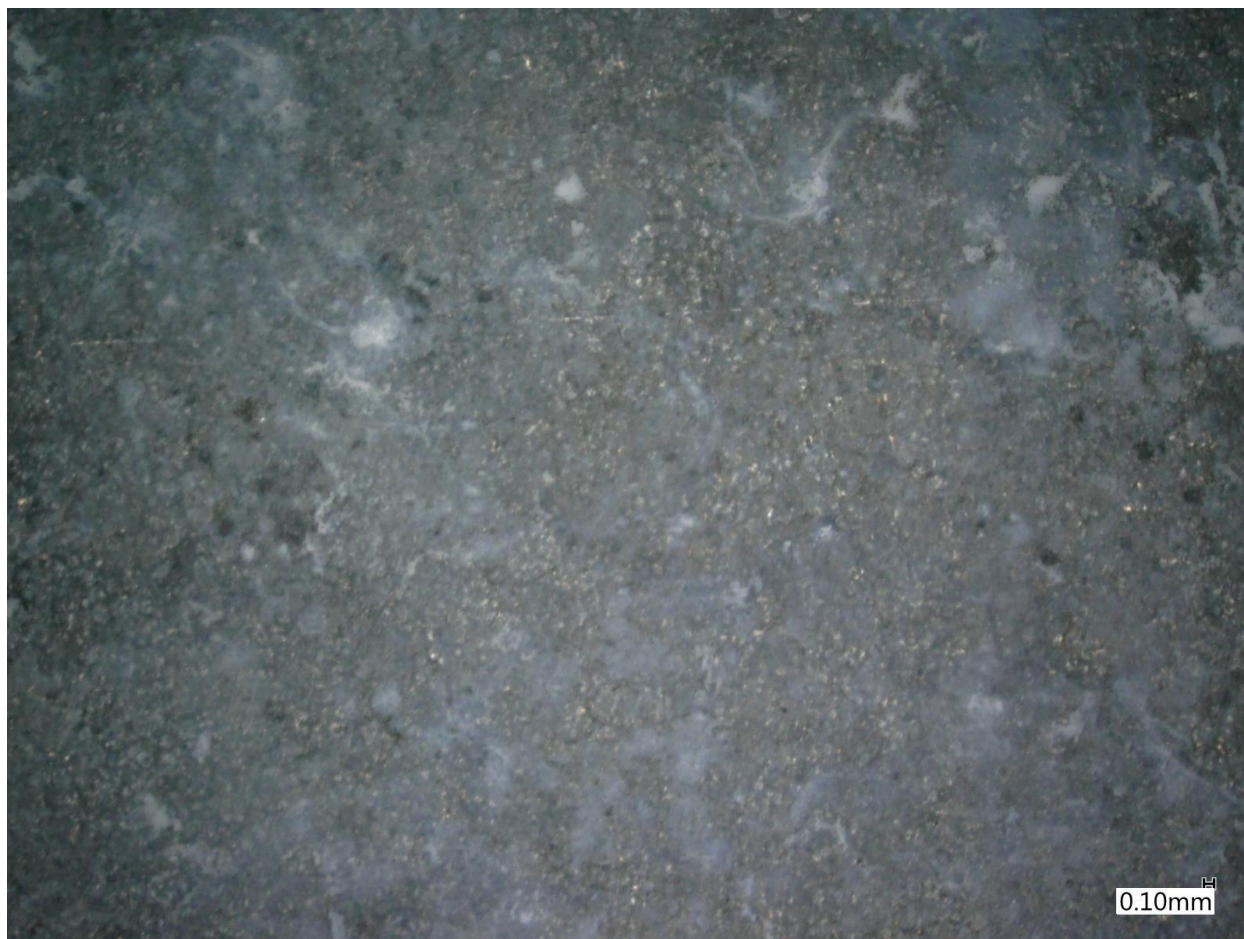
Picture 23: Microscope picture of sample 3 after testing

Picture 25: Microscope picture of sample 3 after testing

Picture 27: Microscope picture of sample 3 after testing

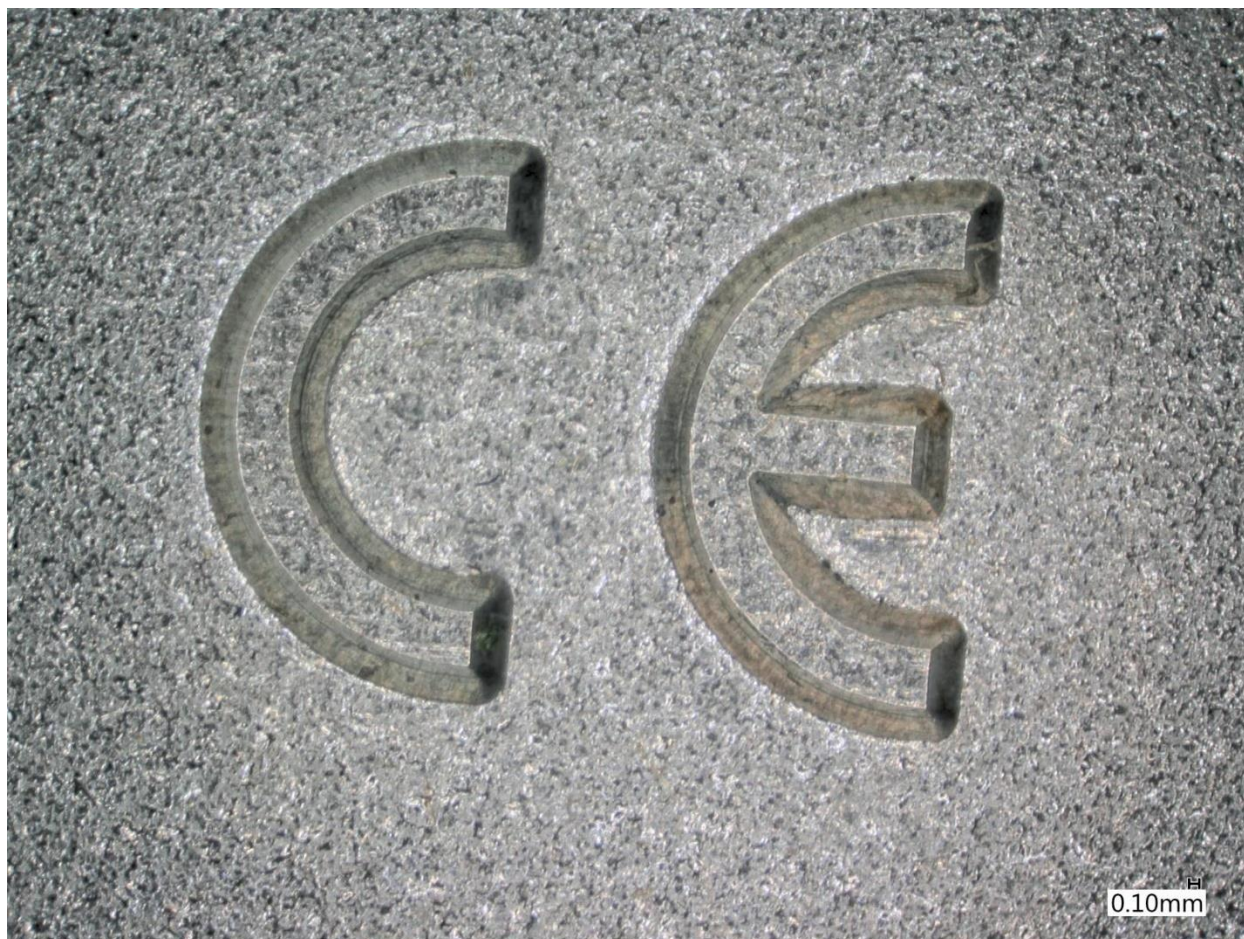
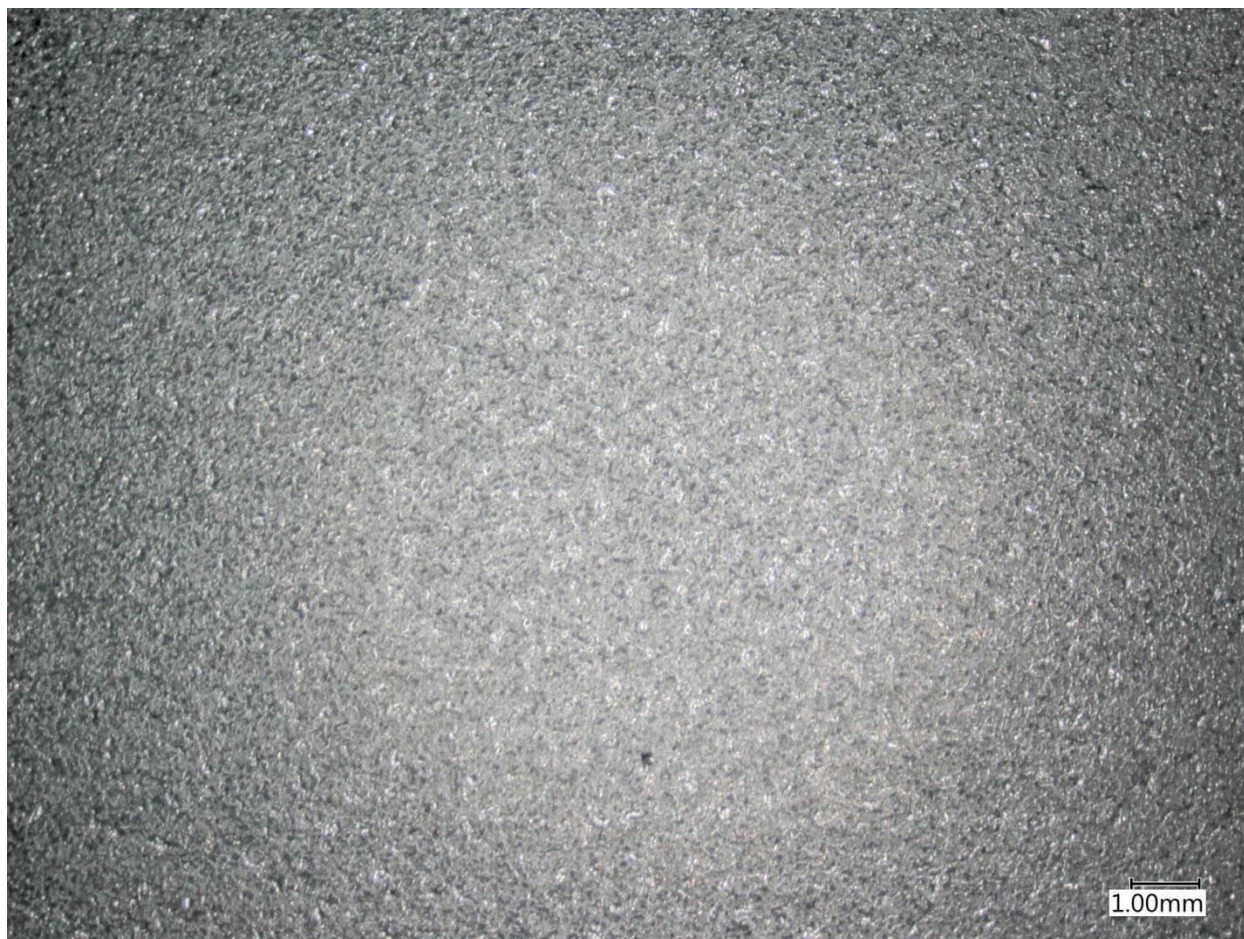
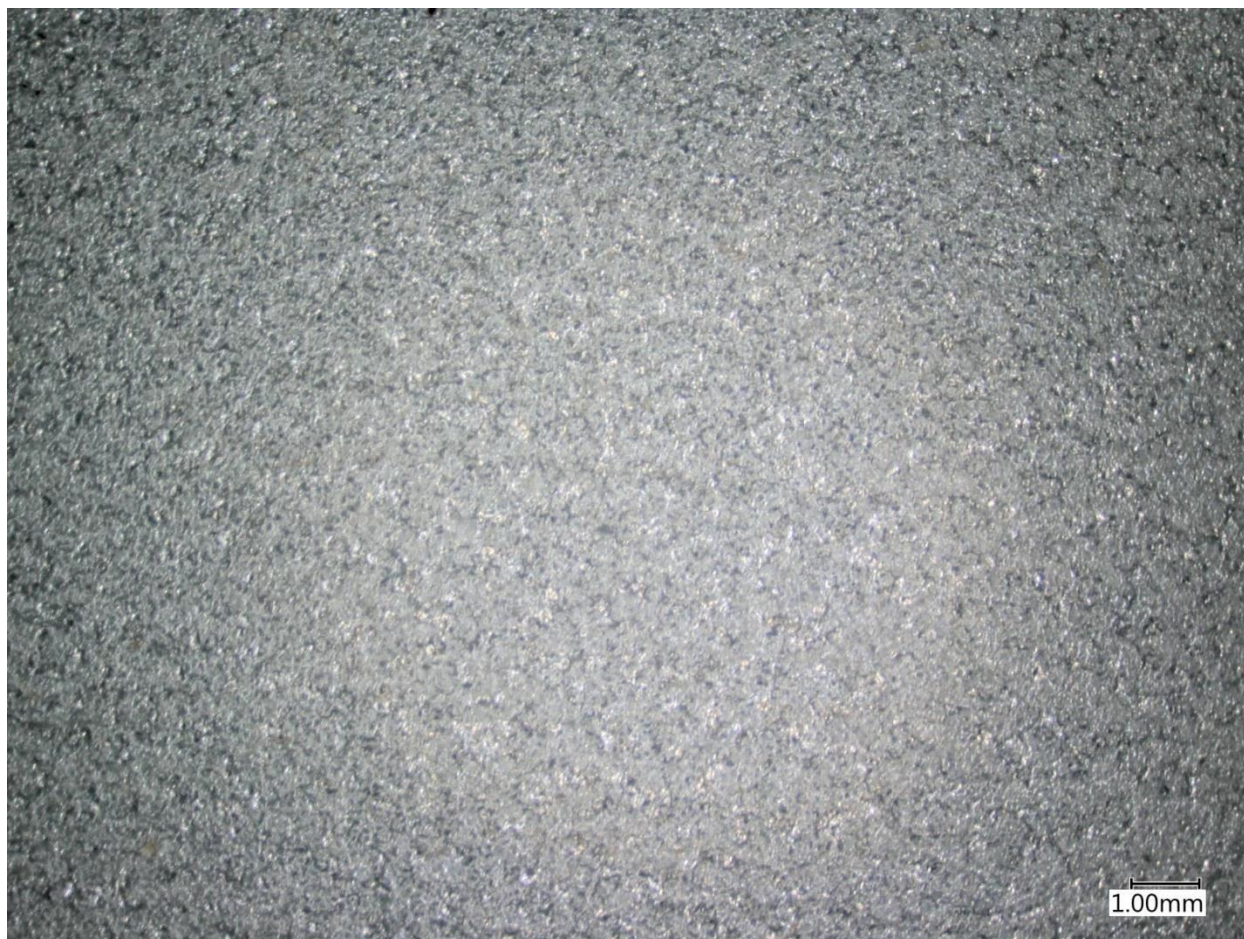
Picture 28: Microscope picture of sample 4 as received

Picture 30: Microscope picture of sample 4 as received

Picture 32: Microscope picture of sample 4 as received

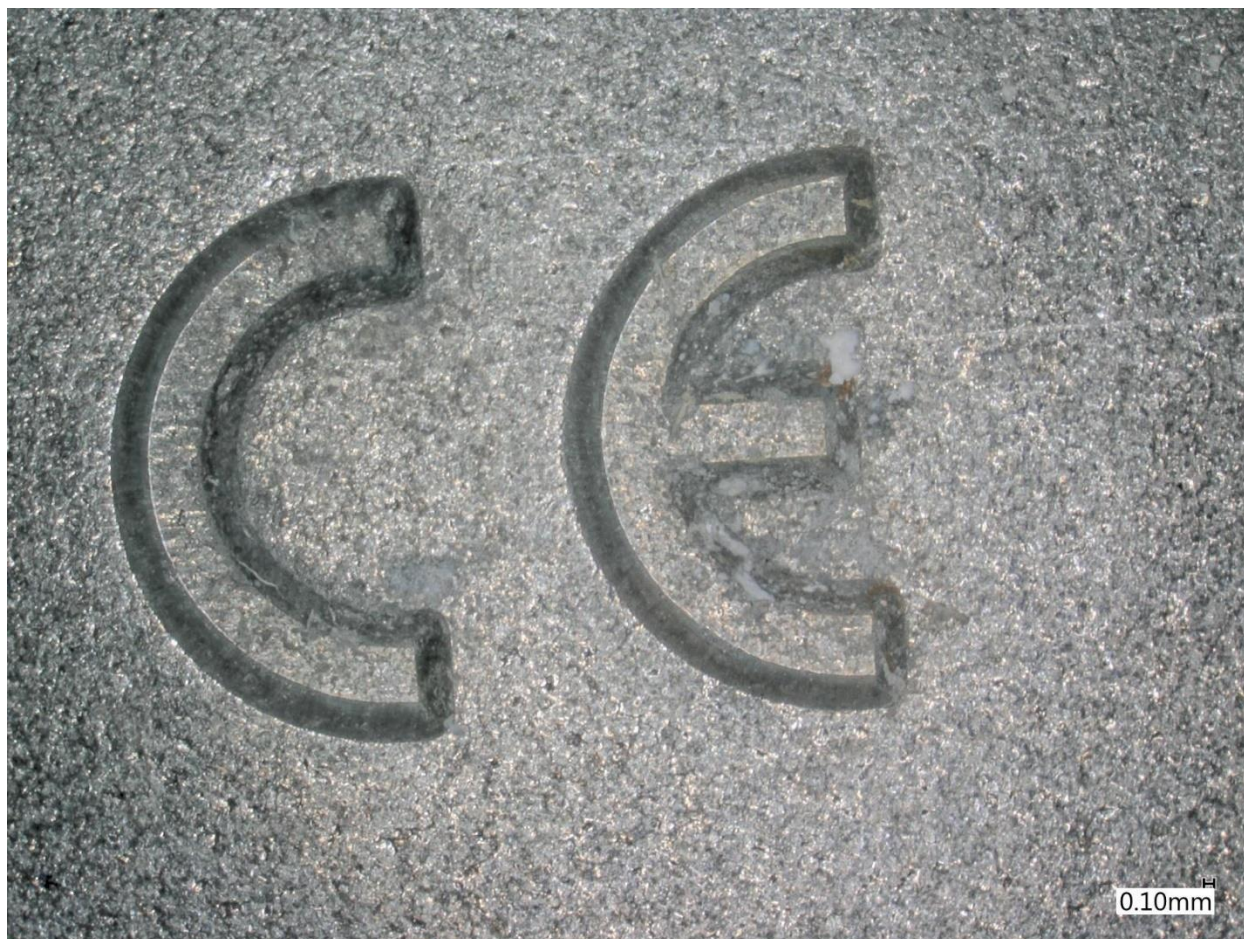
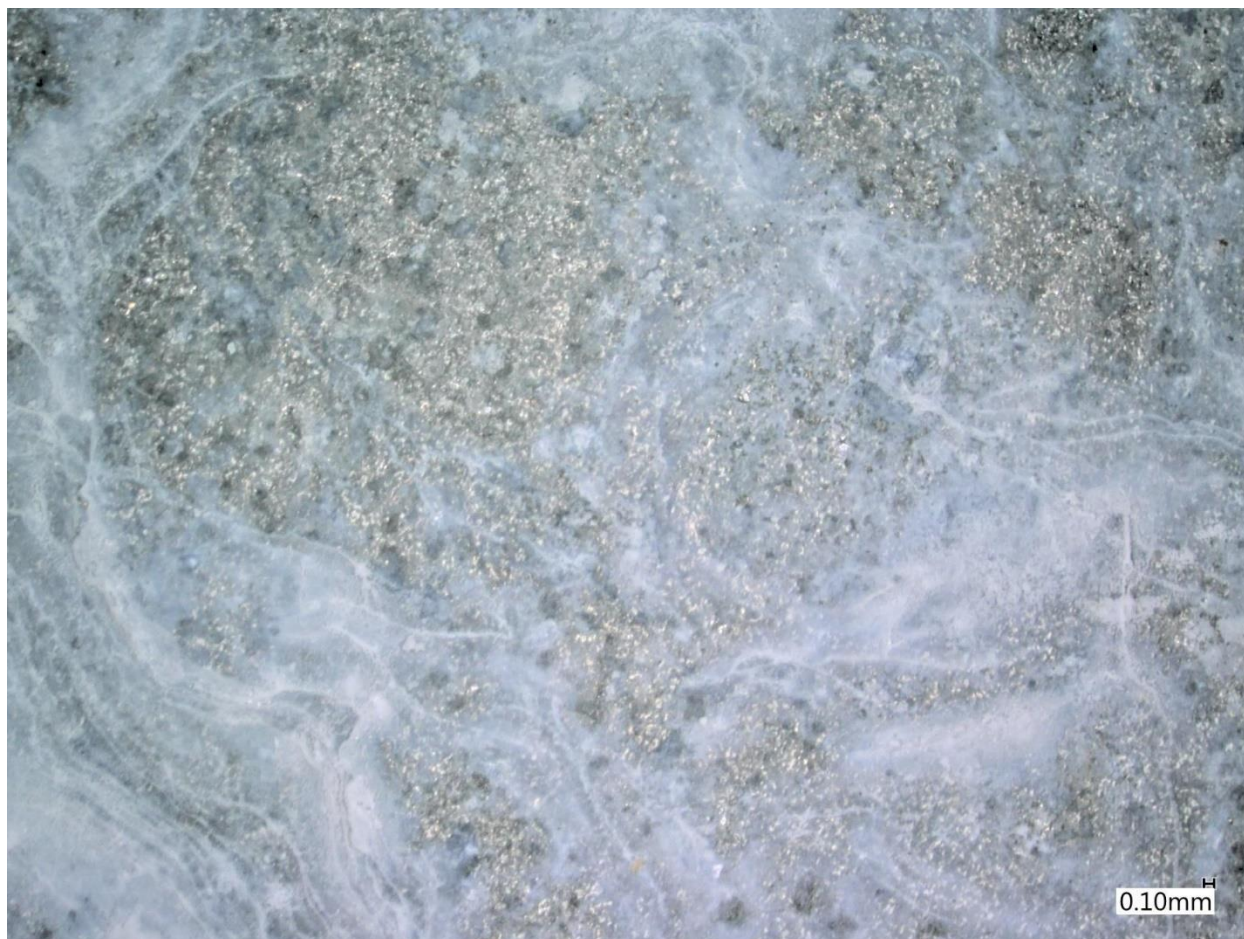
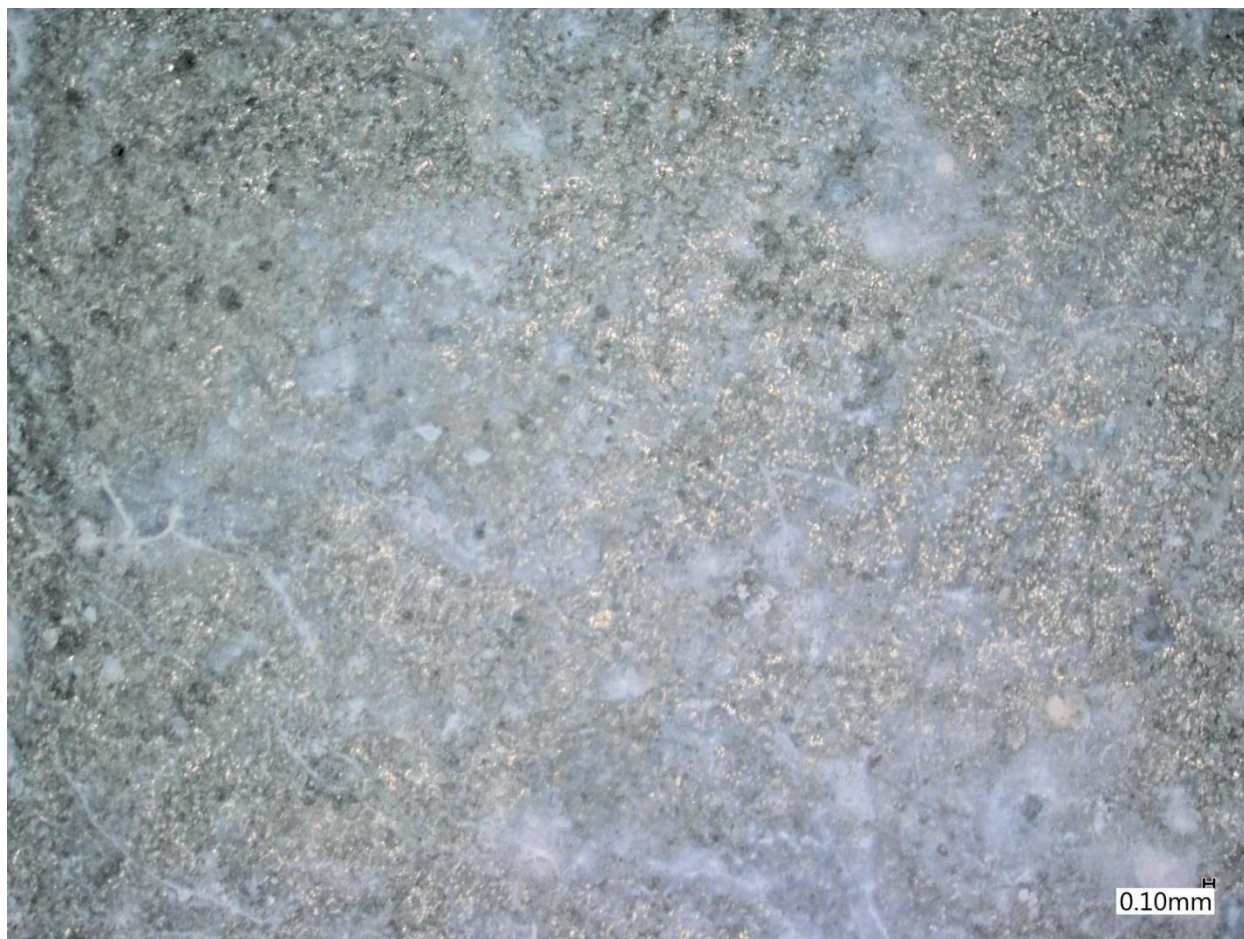
Picture 29: Microscope picture of sample 4 after testing

Picture 31: Microscope picture of sample 4 after testing

Picture 33: Microscope picture of sample 4 after testing
